Bayou State Inspections, LLC
presents a
Qualitative
Infrared Thermographic Survey
Of Electrical Switchgear & Motors
at the Facility of:

Louisiana Housing Corporation
2415 Quail Drive Baton Rouge, LA
July 17-18, 2019

Dates of Survey:
July 17-18, 2019

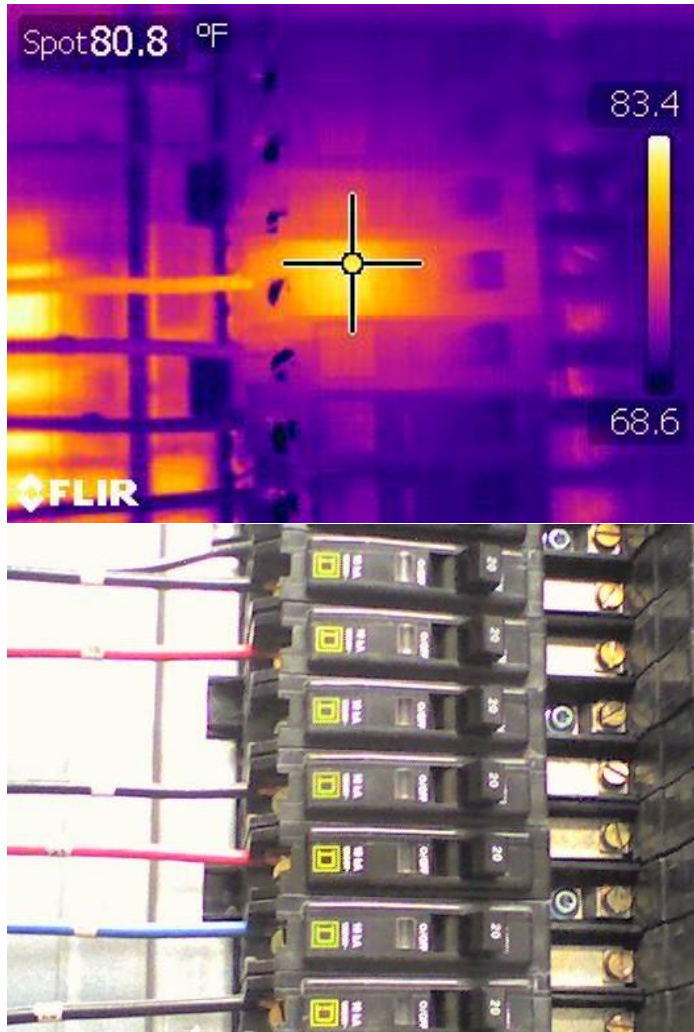
THERMOGRAPHIC REPORT # 1

AREA: Mechanical Room 114

EQUIPMENT: P-1 Section 1

COMPONENT: Circuit 19

81.8 °F

+10 F°

Rating: Minor

Loose Wire at Lug

Tighten Wire at Lug

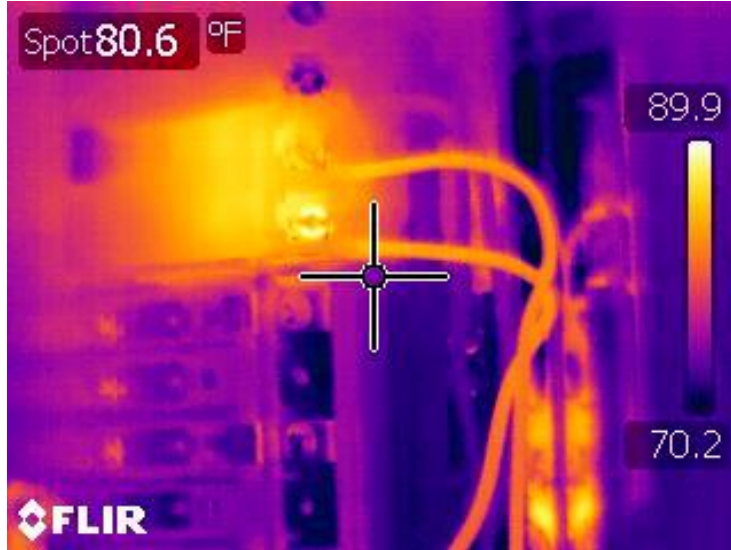
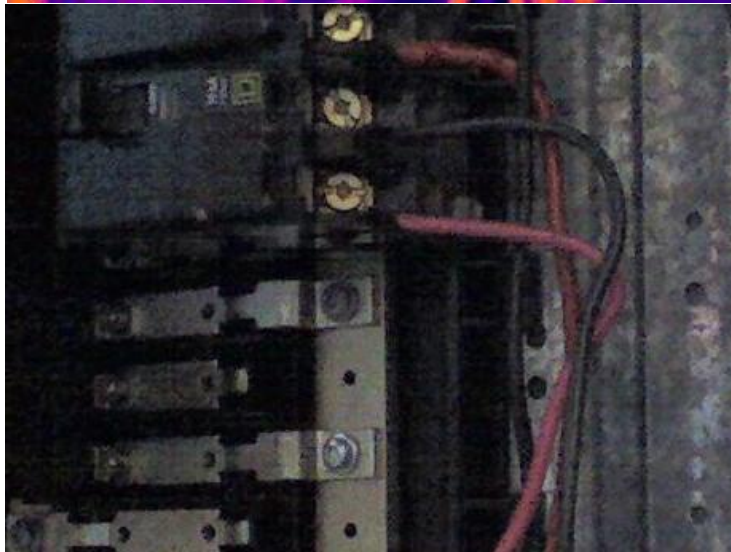
**THERMOGRAPHIC
REPORT # 2**

AREA: Mechanical Room 124
EQUIPMENT: P-1
COMPONENT: Circuits 18 & 20
Date: 07/17/2019
Time: 14:58

Reference Temperature:
 71.2 °F
Maximum Temperature:
 89.5 °F
Temperature Rise:
 +18.3 F°

Rating: Minor

Loose Wire at Lugs and / or Load Side Connection

Tighten Wiring at Lugs and / or Load Side Connections

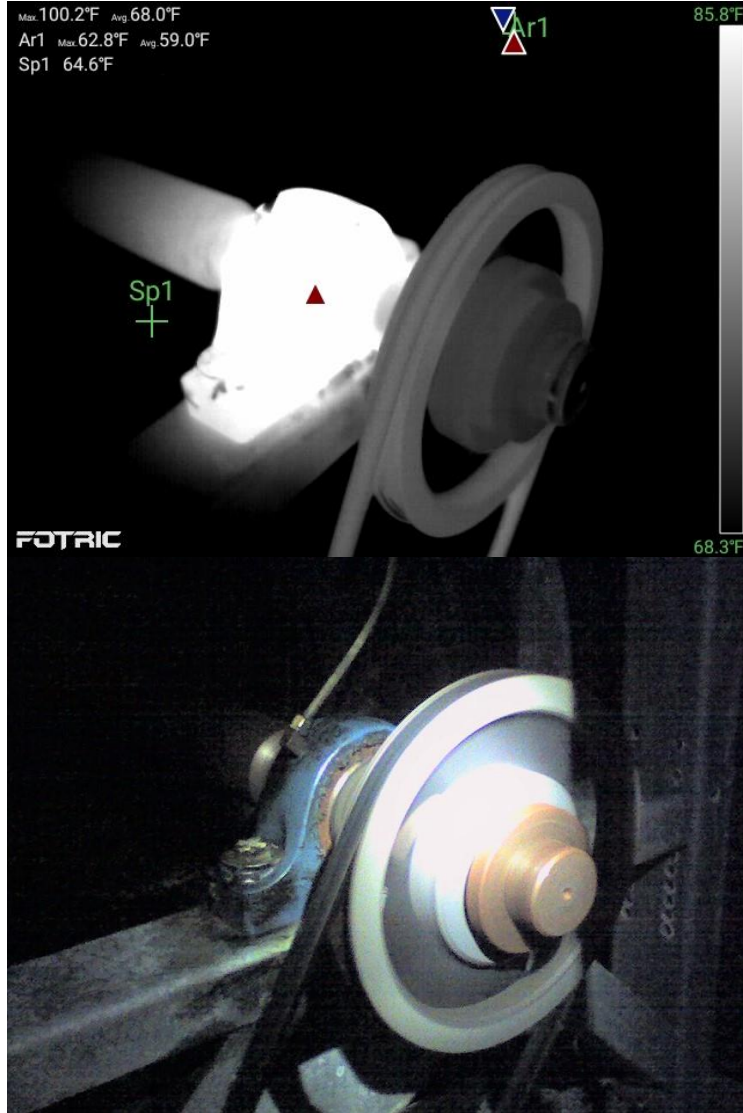
**THERMOGRAPHIC
REPORT # 3**

AREA: Mechanical Room 206

EQUIPMENT: AHU-2 Motor

COMPONENT: Shaft Bearing

100.2 °F

+32.2 F°

Rating: Alert

Overheating Shaft Bearing

Replace Belt, Align Shaft to Motor, and / or Replace Shaft Bearing

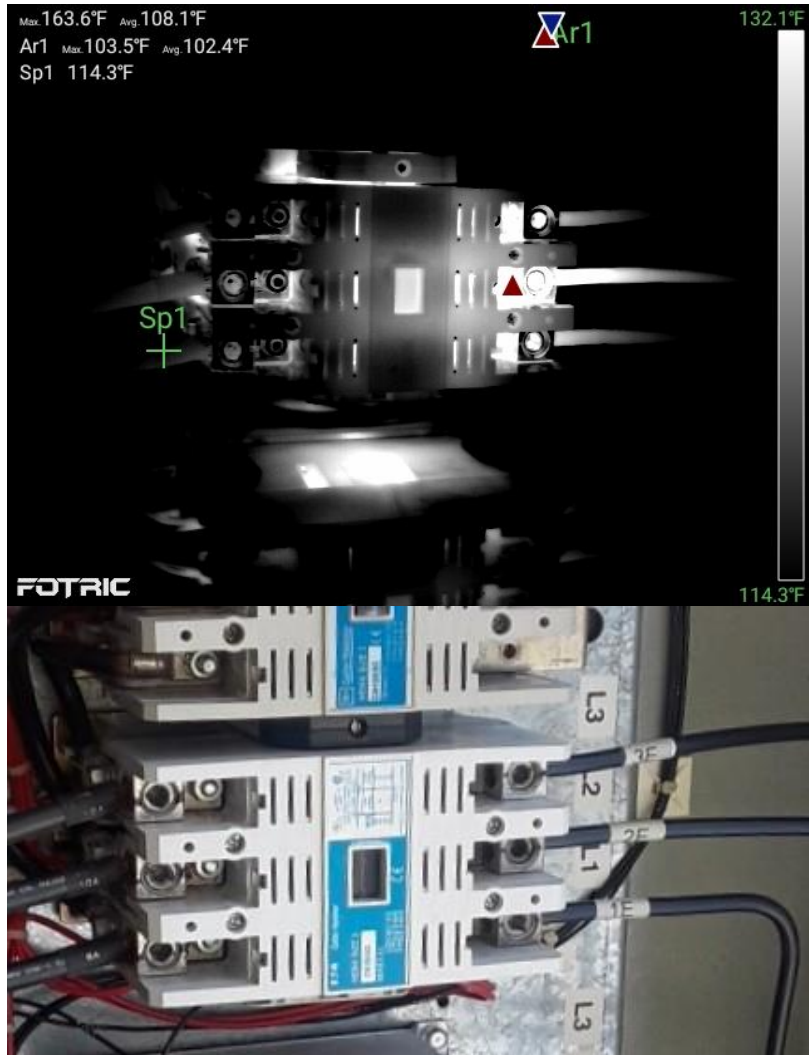
THERMOGRAPHIC REPORT # 4

AREA: Chiller Yard

EQUIPMENT: CH-A Chiller PNL

COMPONENT: Contactor 2E

163.6 °F

+55.5 F°

Rating: Critical

Overheating Contactor E on B Φ

Repair / Replace Fan Motor and / or Contactor 2E
