General Information

Property Address 100 sample drive

Company Name Bayou State Inspections

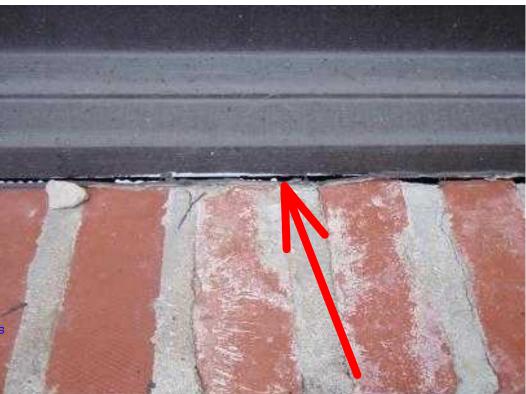
Type: Brick ven erCommon cracking was noted at the brick wall at the windows and doors. large gap was noted at the front right side window; BSI recommend sealing this area.

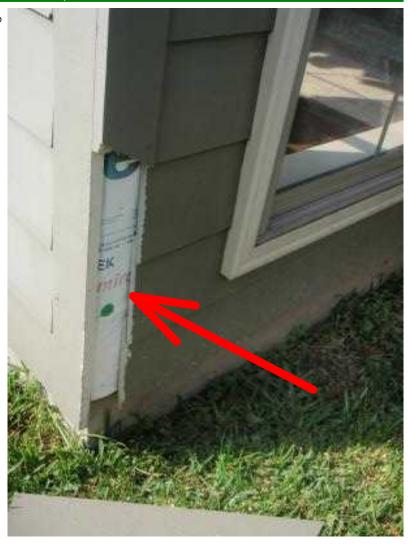
3. Trim: Hardie Siding & Lap Siding Repair/ replace the broken back left corner of the trim board.

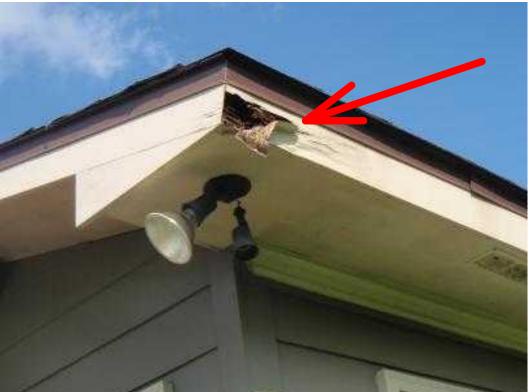
Repair/ replace the water damaged areas at the back right corner of the soffit and fascia. Repair/ replace the water damaged area at the back wall of the master bedroom area as well as all other areas of water

damage.

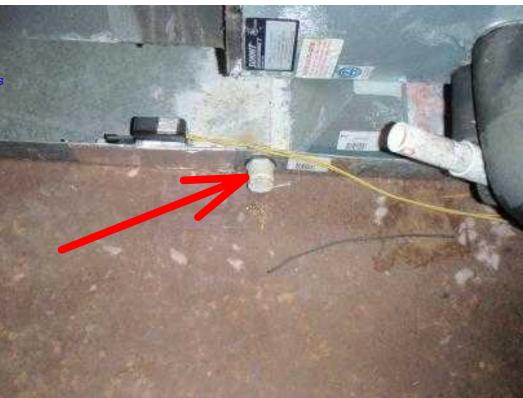
Insulated PVC BSI recommend that the secondary drain pan be piped to the exterior in the event that the float switch fails to operate to allow water to drain out the attic area.

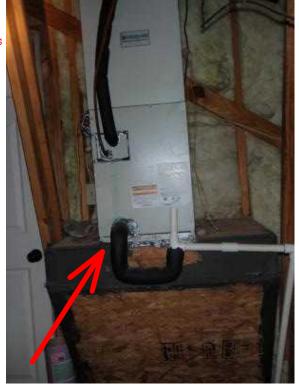
12. Condensate Removal: PVC BSI recommends insulating the PVC primary drain line. BSI noted that no drip pan was present. Replace the missing drip pan for this unit in the attic to prevent water damage from leaking / overflowing of the primary drain

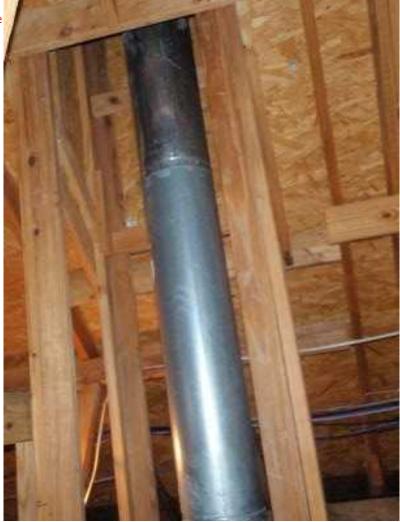
A NP NI M D				
Living Room Firepla	ce 			
1. 🛛 🗌 🗎 🗎	Fireplace Construction: Prefab	Metal Insert		
	or Wood Burning			
3.	Fireplace Insert: Metal			
4.	Smoke Chamber: Metal			
5.	Flue: Metal BSI			1 357
	recommends strapping the	The second second	10 mm	
	flue pipe in the attic	- D		
	at the middle of the	THE RES . LEW	TELLIN MARKET	8 65
	exhaust opening. The	STREET, S. C. CO.

manufacture considers this too be a fire hazard.

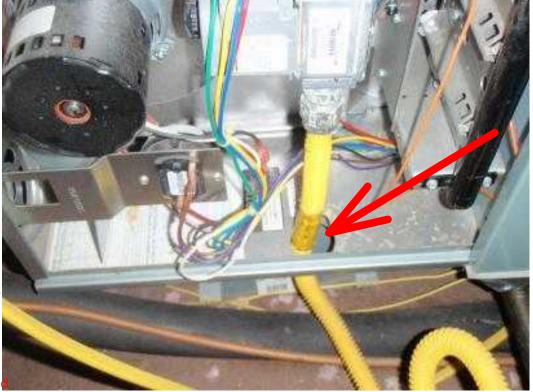
Exchanger: 3 Burner Rigid gas piping is required at the Air Handling Unit and should extend past the furnace cabinet at least 3" before being connected to flexible gas piping. This is

to be a fire & safety hazard and is easily corrected usually with minimal

considere

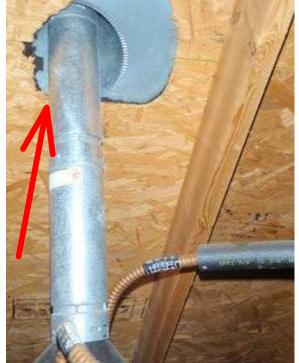
flue pipe and all insulation and or combustible material. Connect the roof jack capping at the water

heater roof flashing.

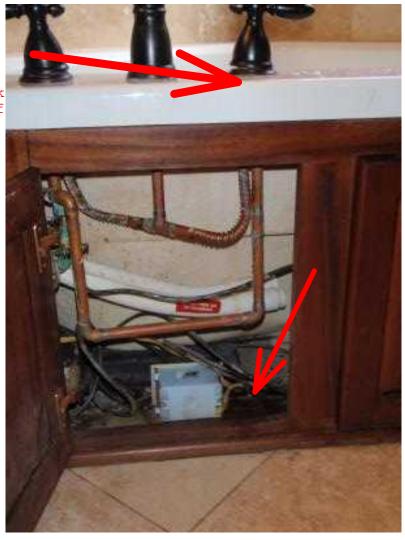
10. Taucets/Traps: Delta fixtures with a PVC "P" trap BSI noted a loose

tub faucet that will need to be secured.
Repair/ replace the leak at the hot water side of

the tub handle.

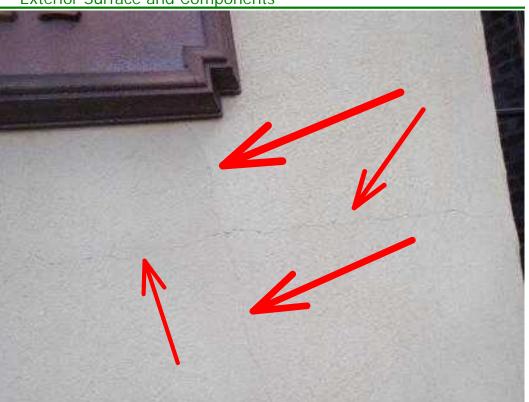
1. Exterior walls Exterior Surface Type: DEFS Stucco The Stucco System or Multi-Component Wall System was visually inspected as well as inspected using various meters (scan & probe type moisture meters) and an infrared thermal imaging camera. Minor cracking was noted under the windows at the time of this inspection. The Stucco was tested using various equipment to detect moisture behind the system, BSI did not note any elevation in moisture at the time of this evaluation.

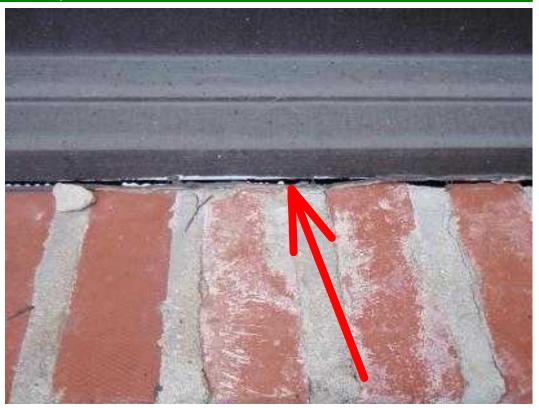
2. Exterior walls Exterior Surface
Type: Brick veneer
Common cracking was
noted at the brick
wall at the windows
and doors. A large
gap was noted at the
front right side
window; BSI recommends
sealing this area.

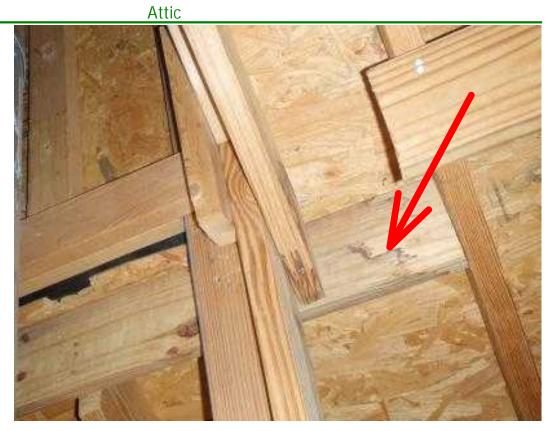
6. Main Attic Moisture
Penetration: No Previous
water penetration
noted Moisture stains
in attic below the
chimney are noted;
this area was tested
and found to be dry
(inactive) with a
moisture reading of
10.3% MC (moisture
content).

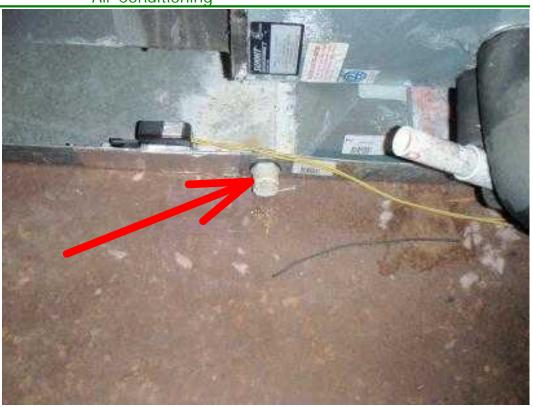
7. Unit #1 AC System
Condensate Removal:
Insulated PVC BSI
recommends that the
secondary drain pan be
piped to the exterior
in the event that the
float switch fails to

operate to allow water to drain out the attic

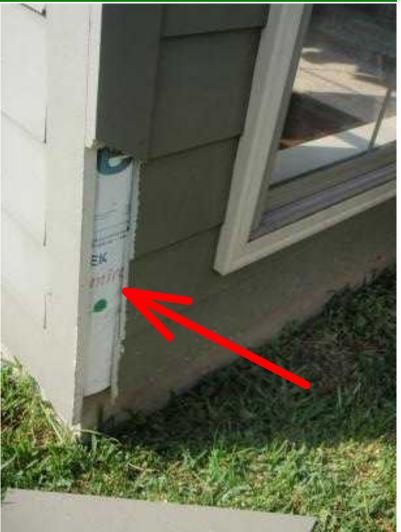
Trim: Hardie Siding & Lap Siding Repair/ replace the broken back left corner of the trim board.

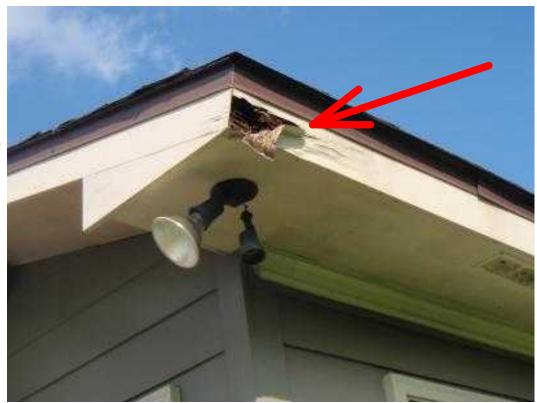
2. Fascia: Wood Repair/
replace the water
damaged areas at the
back right corner of
the soffit and fascia.
Repair/ replace the
water damaged area at
the back wall of the
master bedroom area as
well as all other
areas of water damage.

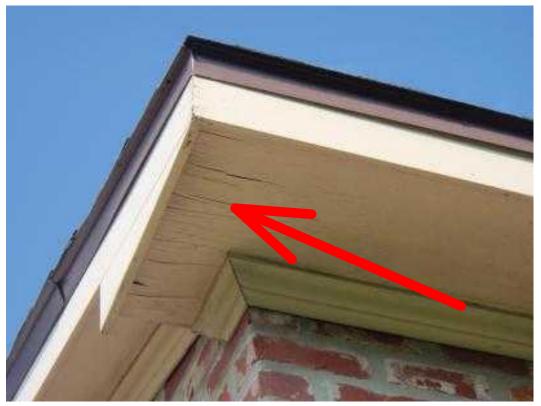
3. Soffits: Wood Repair/
replace the water
damaged areas at the
back right corner of
the soffit and fascia.
Repair/ replace the
water damaged area at
the back wall of the
master bedroom area as
well as all other
areas of water damage.

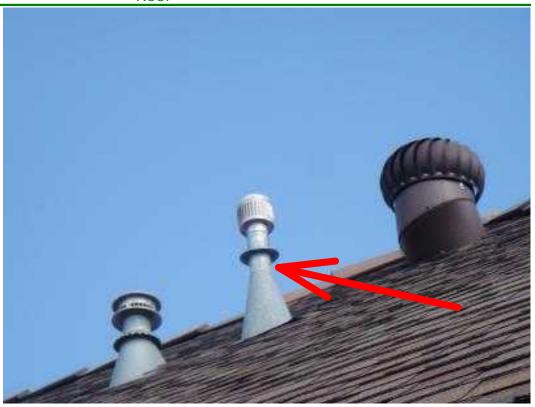
5. Flashing: Metal Move the cap flashing in the proper position at the water heater roof jack.

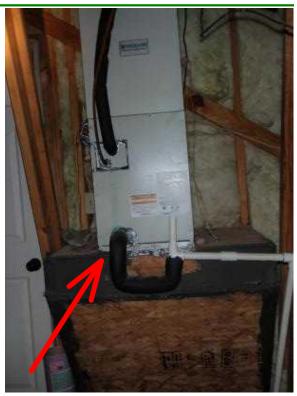
7. Unit #2 AC System Condensate Removal: PVC BSI recommends insulating the PVC primary drain line. BSI noted that no drip pan was present. Replace the missing drip pan for this unit in the attic to prevent water damage from leaking / overflowing of the primary drain line.

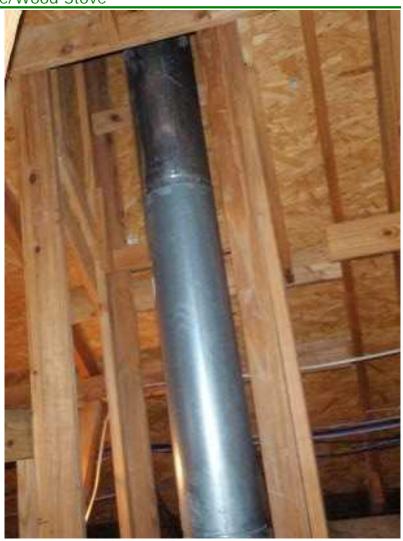
8. Living Room Fireplace Flue: Metal BSI recommends strapping the flue pipe in the attic at the middle of the exhaust opening. The manufacture considers this too be a fire hazard.

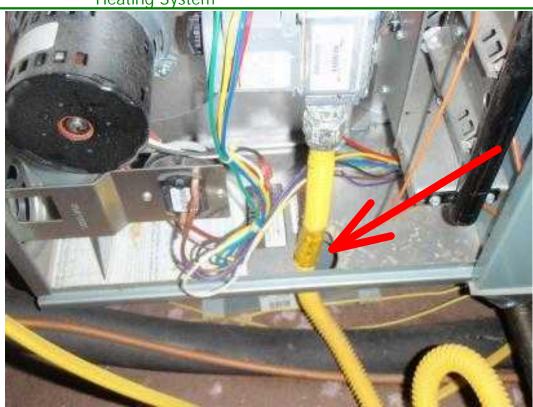
9. Attic Heating System Heat
Exchanger: 3 Burner
Rigid gas piping is
required at the Air
Handling Unit and
should extend past the
furnace cabinet at
least 3" before being
connected to flexible
gas piping. This is
considered to be a
fire & safety hazard
and is easily
corrected usually with
minimal costs.

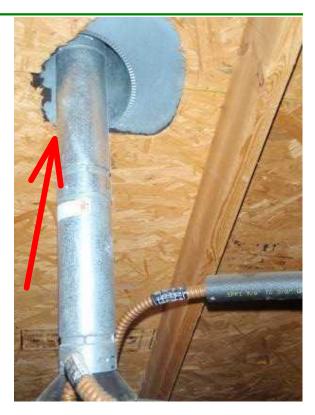
11. Attic Water Heater Flue Pipe: Type B Vent The flue pipe at the Water Heater must be properly secured and strapped allowing a minimum 1" air space between the flue pipe and all insulation and or combustible material. Connect the roof jack capping at the water heater roof flashing.

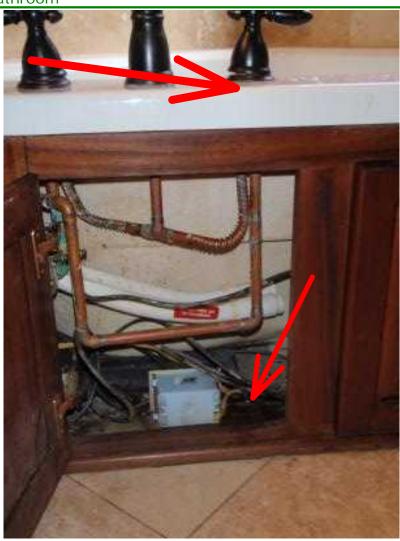
12. Master Bathroom Faucets/Traps: Delta fixtures with a PVC "P" trap BSI noted a loose tub faucet that will need to be secured. Repair/ replace the leak at the hot water side of the tub handle.

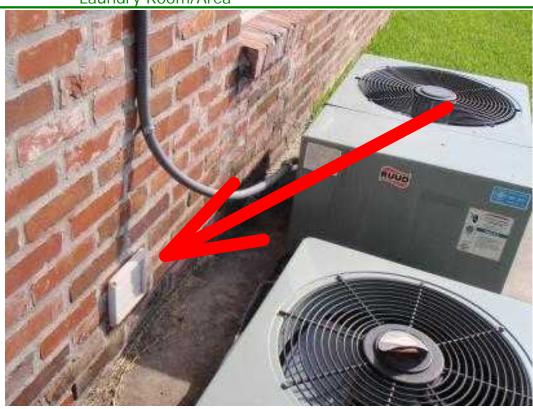
16. Laundry Room Laundry
Room/Area Dryer Vent:
Vented to the exterior
@ HVAC units BSI
recommends installing
a vent trap or moving
the vent 5' away from
the HVAC units.
