Qualitative Infrared Thermographic Survey of Electrical Distribution Systems

Abdalla Hall
Lafayette, LA

January 29th, 2018

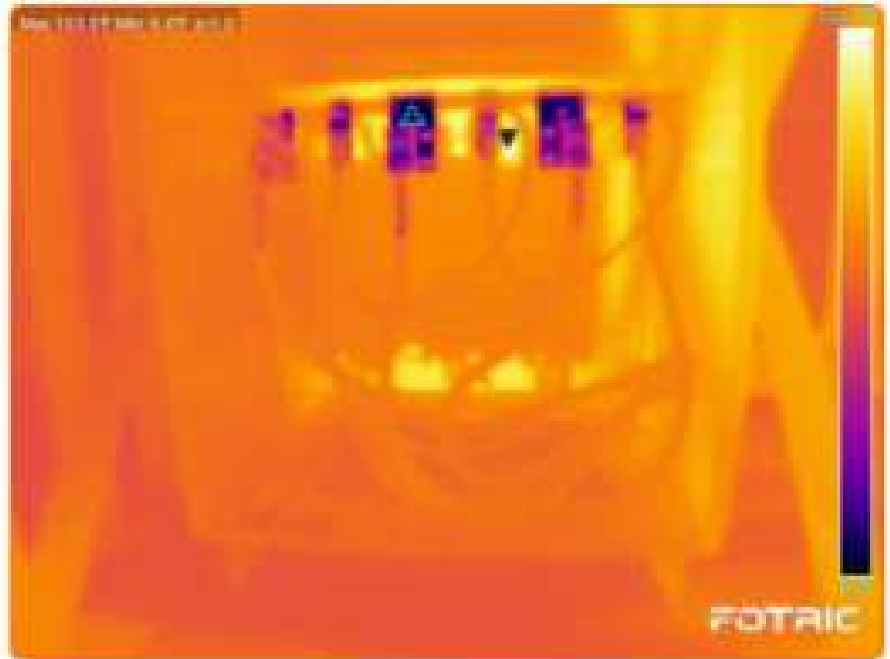
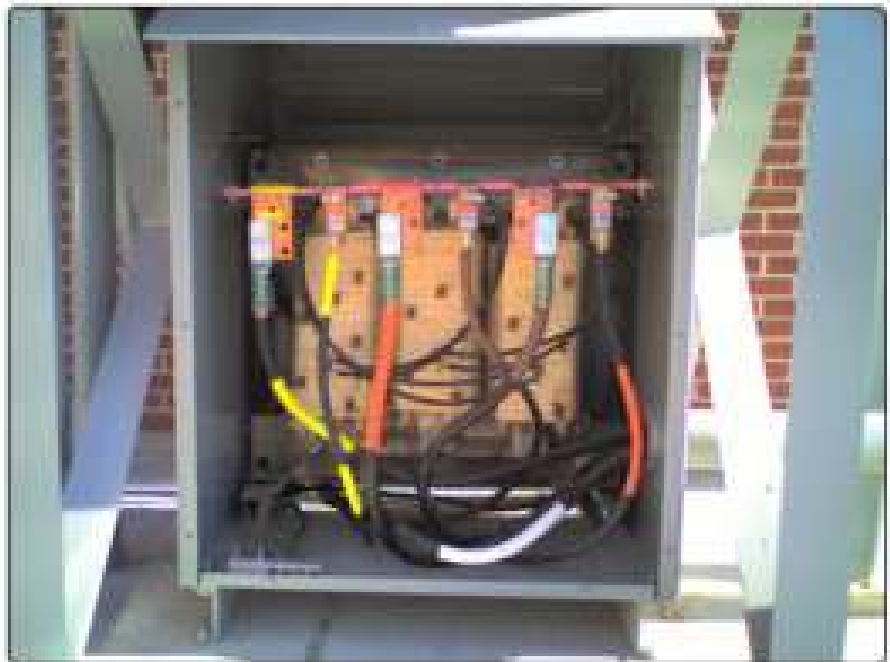
Thermographic Report # 1

Ambient Temp:	64F
Reference Temp:	67F
High Temp:	67.6F
Temperature Rise:	.6F

No findings noted

None

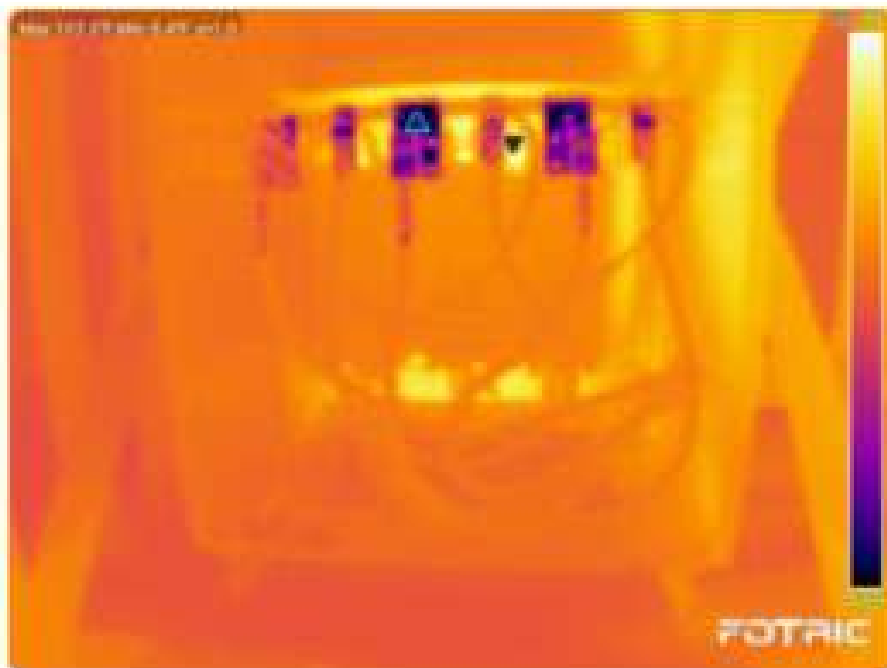
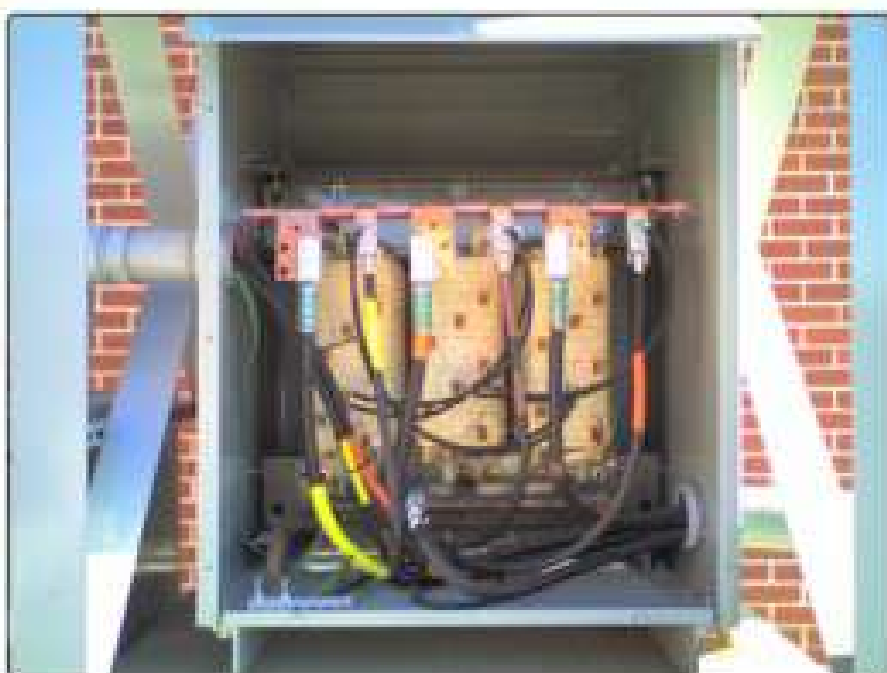
Thermographic Report # 1

Ambient Temp:	64F
Reference Temp:	66.9F
High Temp:	67.4F
Temperature Rise:	.5F

No findings noted.

None.

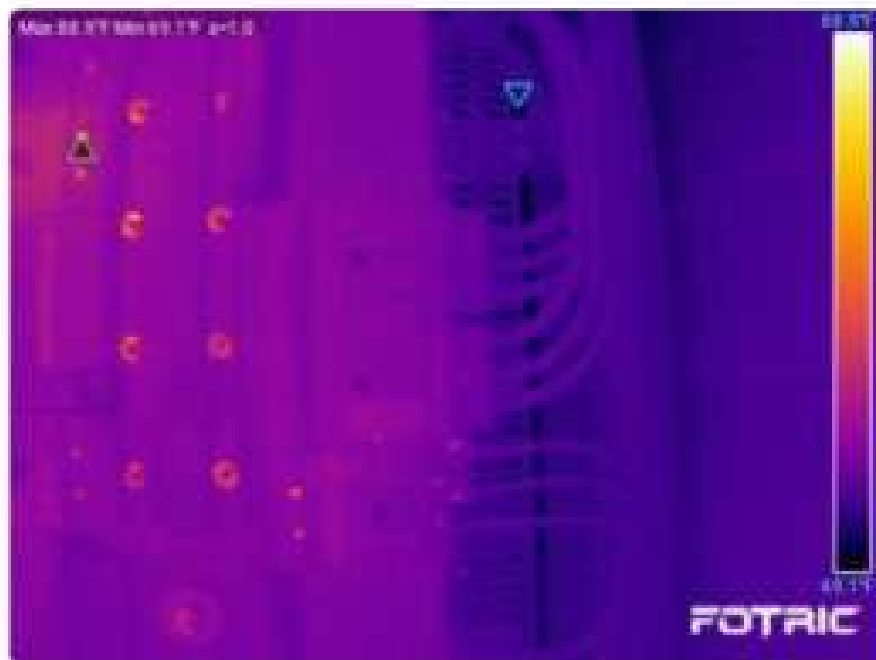
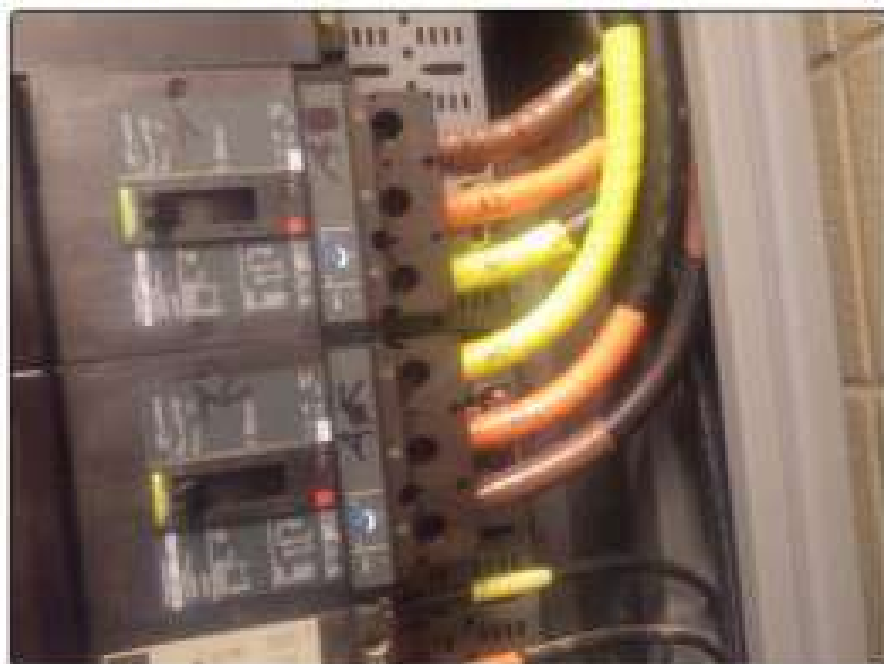
Thermographic Report # 2

Ambient Temp:	74F
Reference Temp:	76.2F
High Temp:	78.2F
Temperature Rise:	0F

No findings noted.

None.

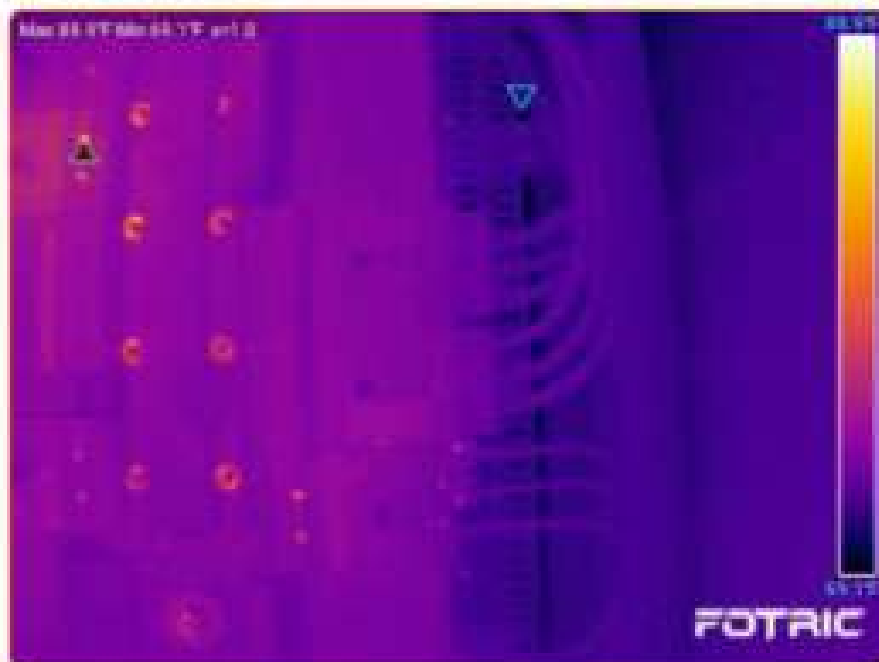
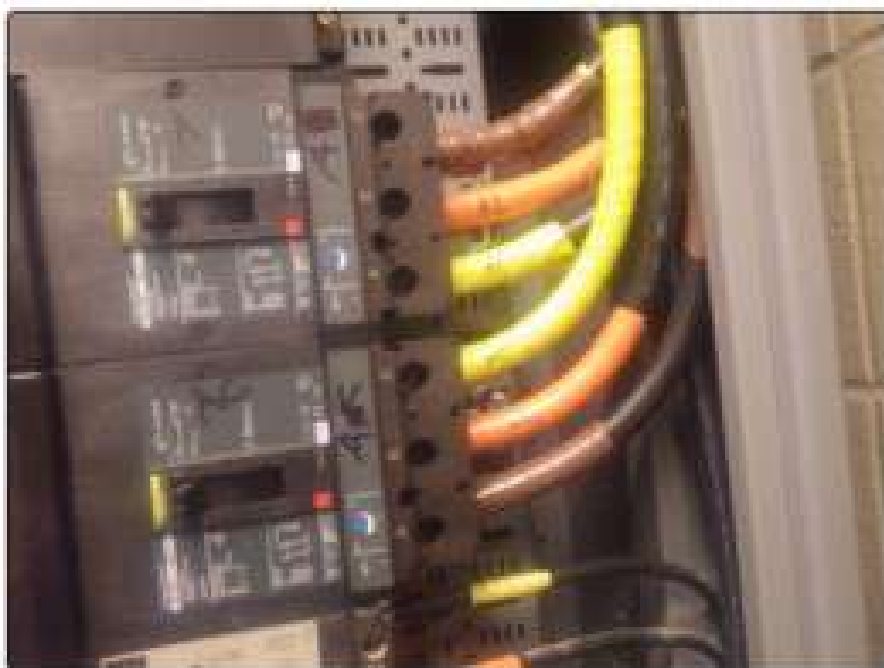
Thermographic Report # 2

Ambient Temp:	74F
Reference Temp:	76.2F
High Temp:	78.2F
Temperature Rise:	0F

No findings noted.

None.

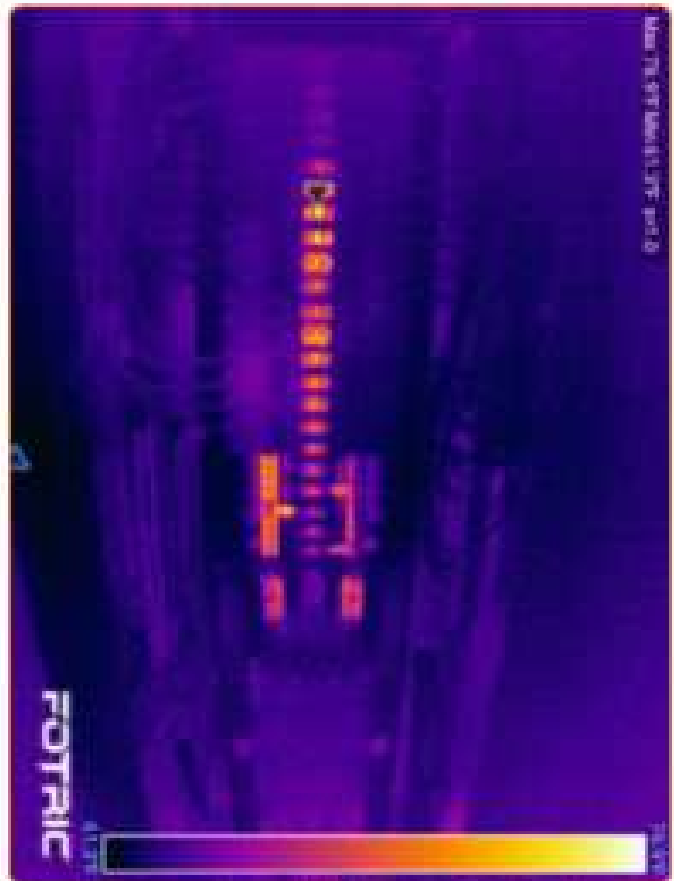
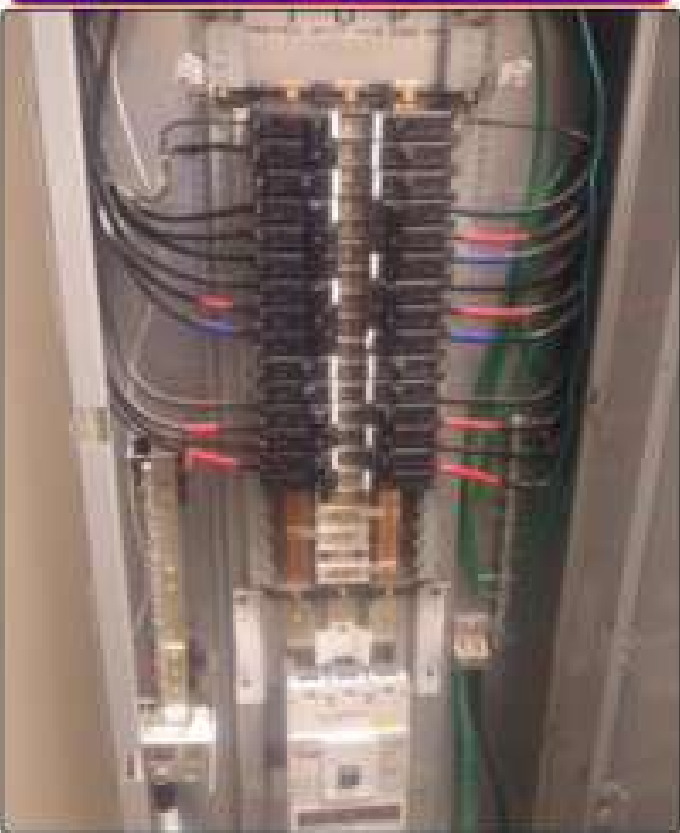
Thermographic Report # 3

Ambient Temp:	60F
Reference Temp:	64.5F
High Temp:	64.9F
Temperature Rise:	0F

No findings noted.

None.

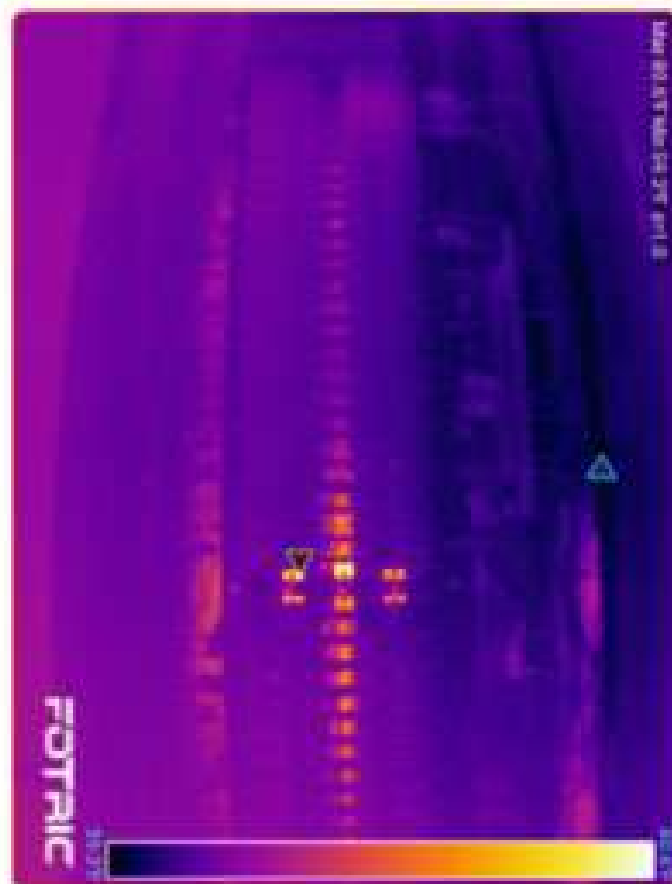
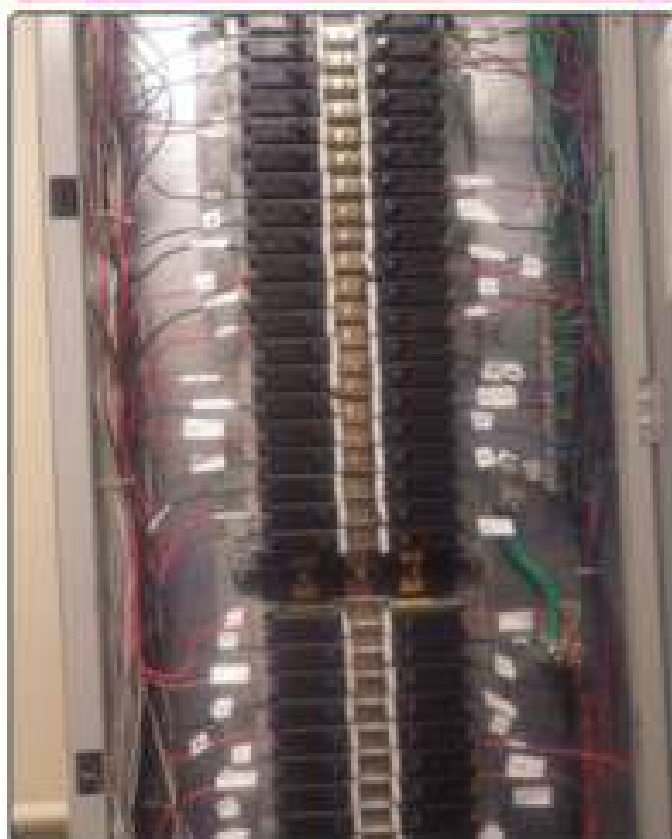
Thermographic Report # 3

Ambient Temp:	60F
Reference Temp:	64.5F
High Temp:	64.6F
Temperature Rise:	0F

No findings noted.

None.
