Bayou State Inspections

Infrared Building Envelope Scan Report

2415 Quail Drive
Baton Rouge, LA 70808

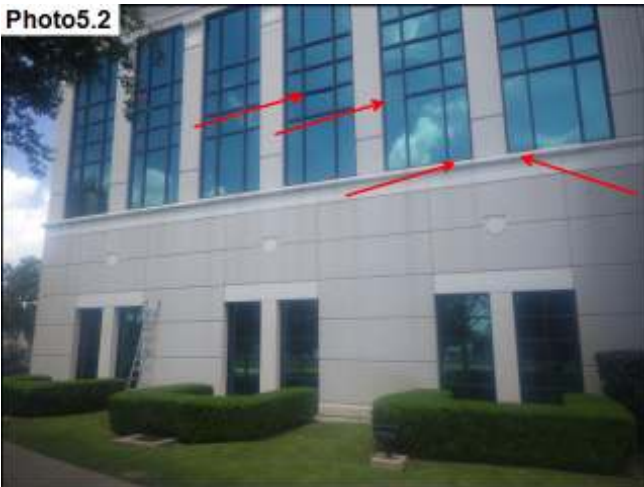
Photo5.2

Front Left (West) Side

Loose and missing trim at the upper sections of the windows

Leaking noted at the bottom of the large second and third floor windows causing water damage at the top and sides of the windows on the inside along this interior hallway.

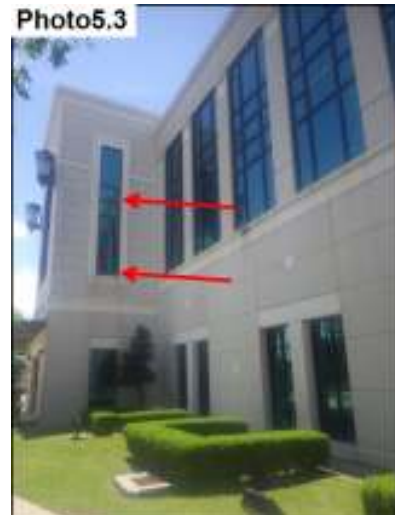
Photo5.3

The large front entrance windows on the East and West Sides leak allowing water damage inside the building at the large plaster sills. These windows leak at the trim / rubber gasket areas as well as at the bottom corners.

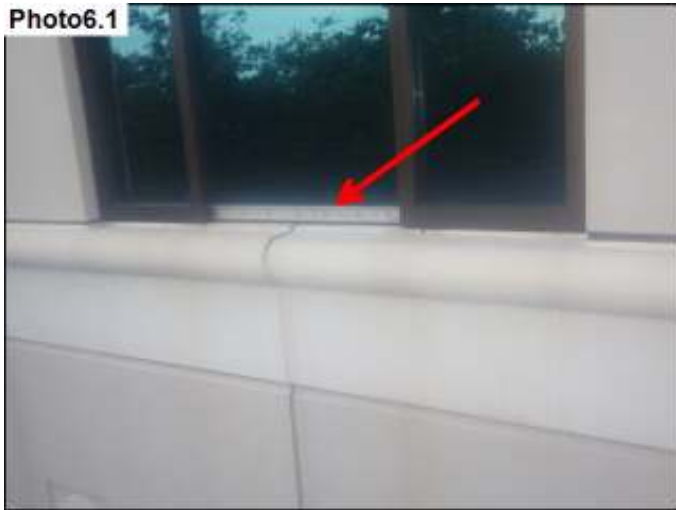
Missing trim flashing at the front left wall upper window

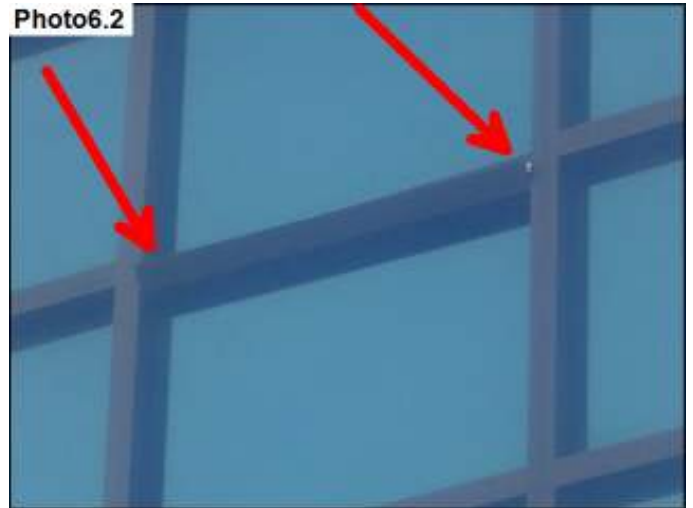
Loose trim at the front left side upper window

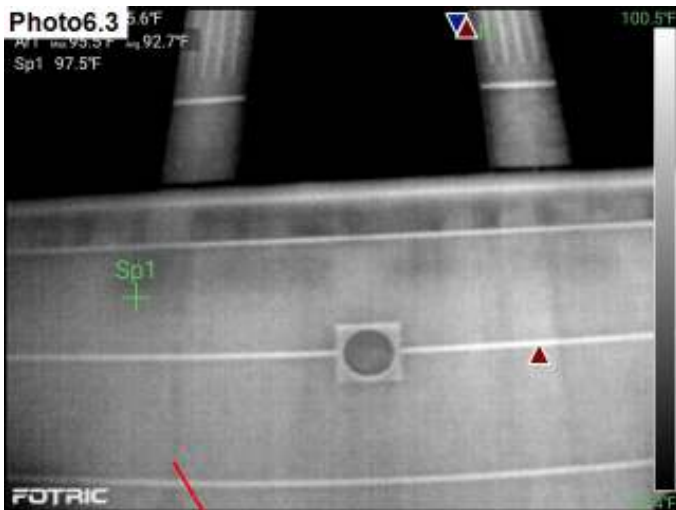
Front left side wall IR photo taken after sunset. The wall is not leaking; however, the windows are allowing moisture behind them to the inside drywall walls along the front left hall.

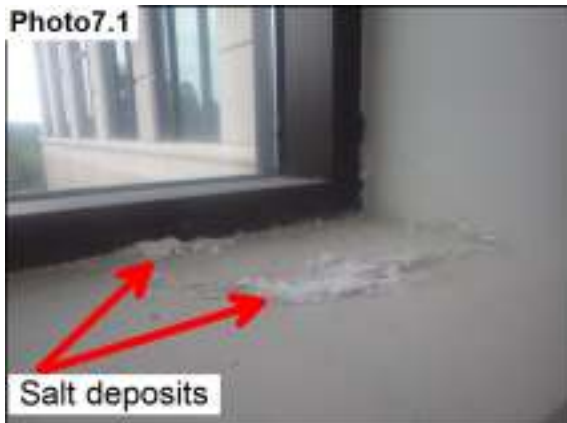
Salt deposits (water damage) from the elevated moisture in the plaster of the front entrance windows

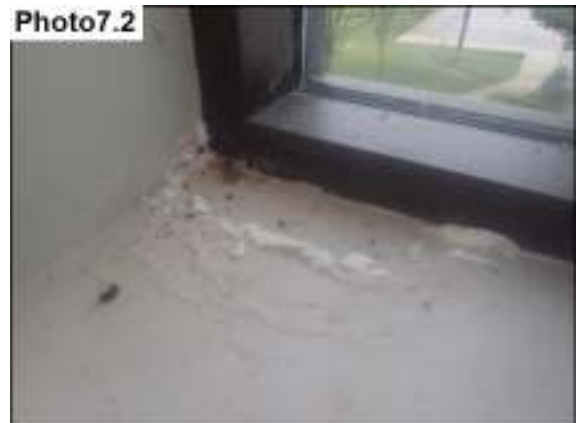
Salt deposits (water damage) from the elevated moisture in the plaster of the front entrance windows.

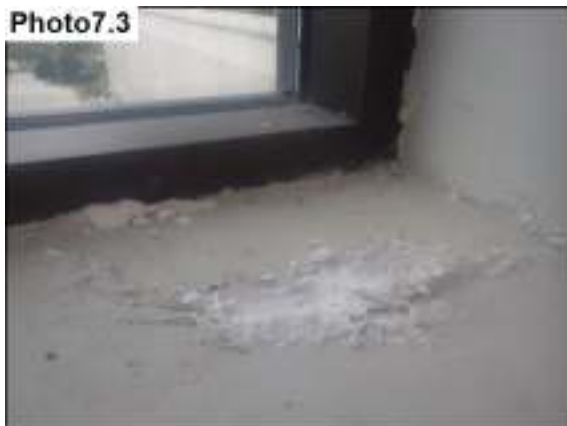
Salt deposits (water damage) from the elevated moisture in the plaster of the front entrance windows.

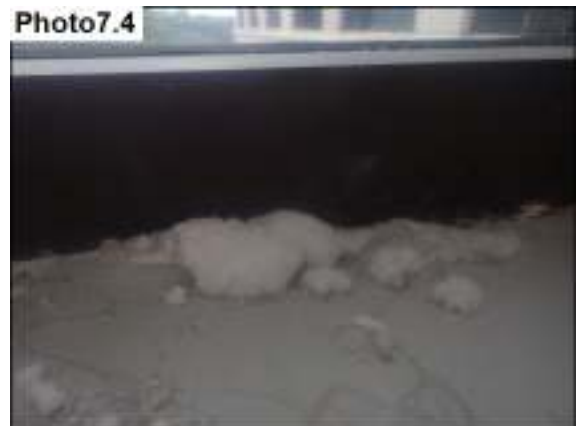
Salt deposits (water damage) from the elevated moisture in the plaster of the front entrance windows.

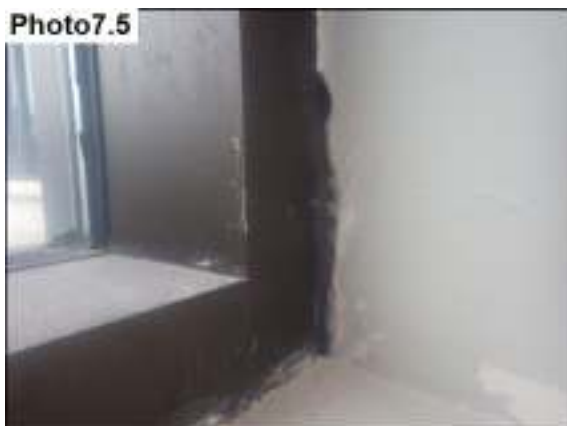
Large crack at the bottom of the front entrance windows; repair after the leaking is corrected.

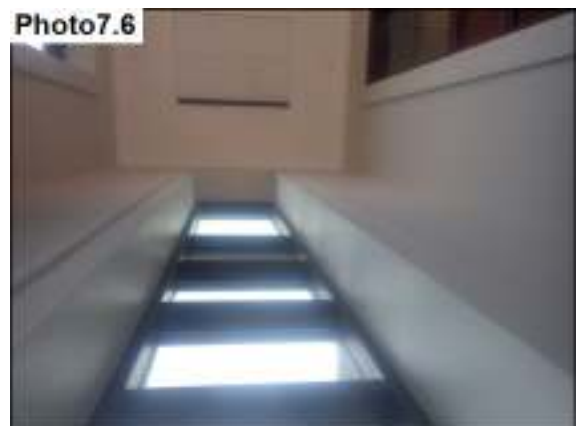
The vent at the ceiling is cooling the window frame, which allows condensation at the window.

3. The front windows have condensation that also causes water damage due to the location of the HVAC supply ducts. Move the supply ducts from the outer section of the ceiling to the interior section to stop the cold supply air from cooling the metal window trim, which is allowing condensation to form and drip down to the bottom of the windows.

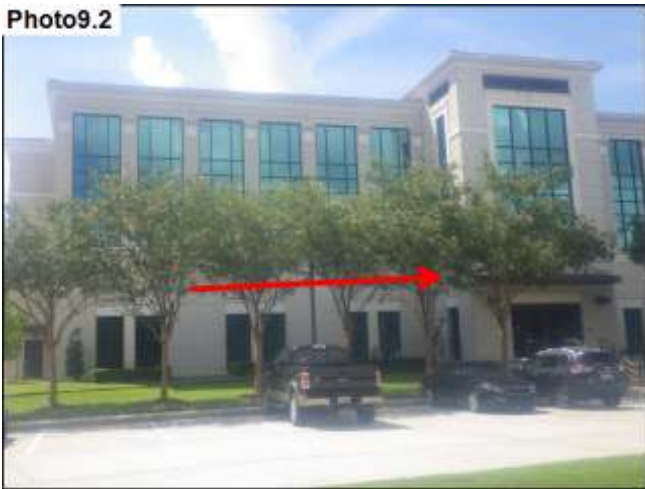
Photo9.2

Back (North) Elevation
Arrow marks area of leak.

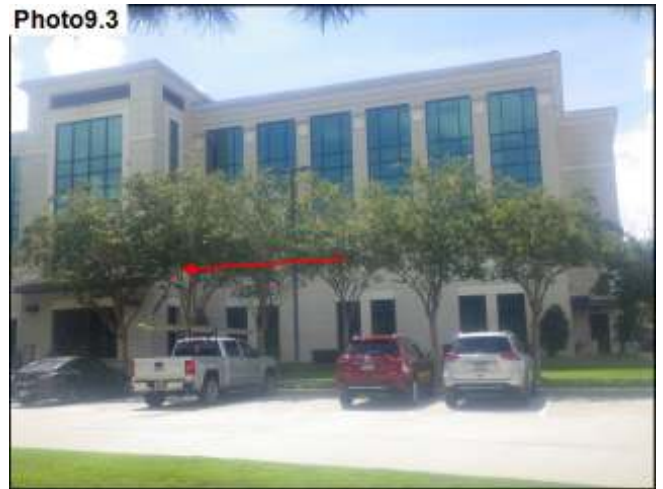
Photo9.3

Back (North) Elevation
Arrow marks area of leak.

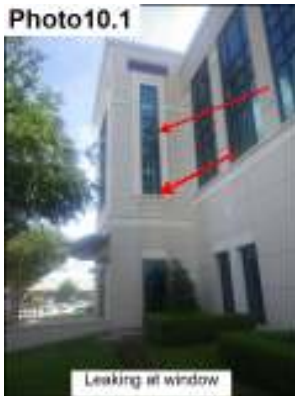
Back Entrance right side upper window leaks at the base

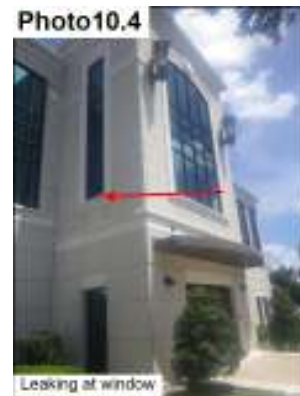
Back Entrance left side upper window leaks at the base.

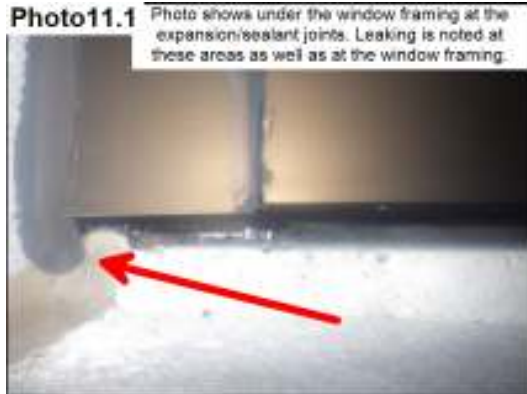
Leaking at the bottom of the Back Entrance East facing window
Bottom of window photo

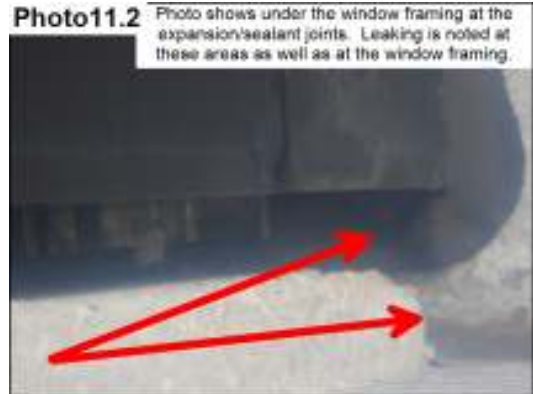
Leaking at the bottom of the Back Entrance East facing window.
Bottom of window photo.

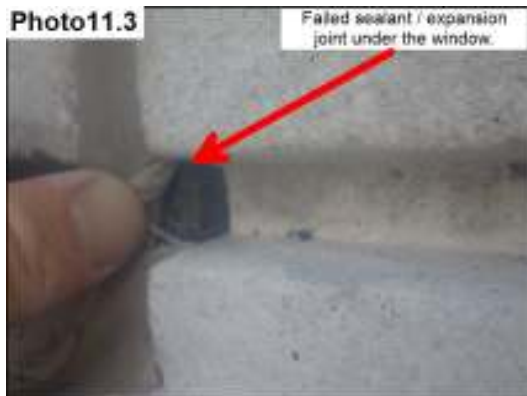
Leaking at the bottom of the Back Entrance East facing window.
Sealant Joint photo.

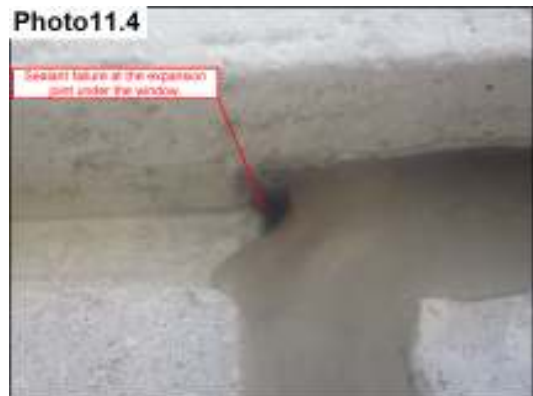
Leaking at the bottom of the Back Entrance East facing window.
Sealant Joint photo.

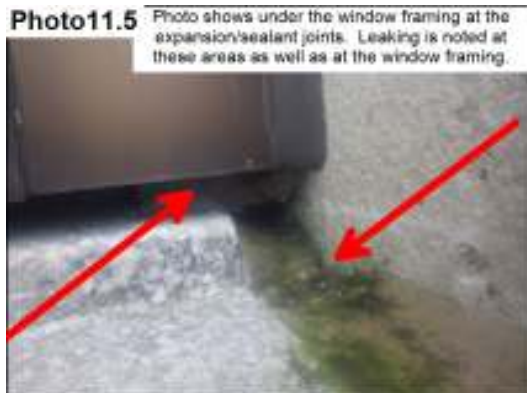
Leaking at the bottom of the Back Entrance East facing window.
Sealant Joint photo.

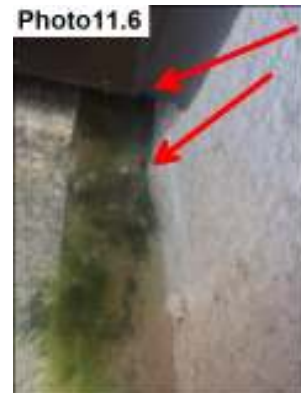
Leaking at the bottom of the Back Entrance East facing window.
Sealant Joint photo.

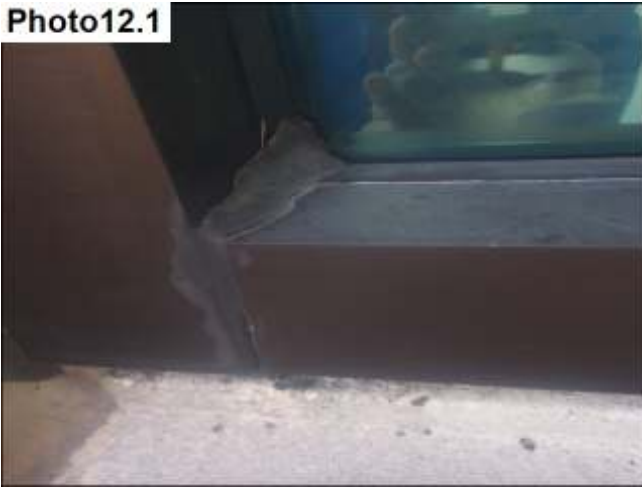
Photo12.1

Repairs noted at the windows from the outside or exterior of the trim. Repairs must be made under the trim at the windows to be effective.

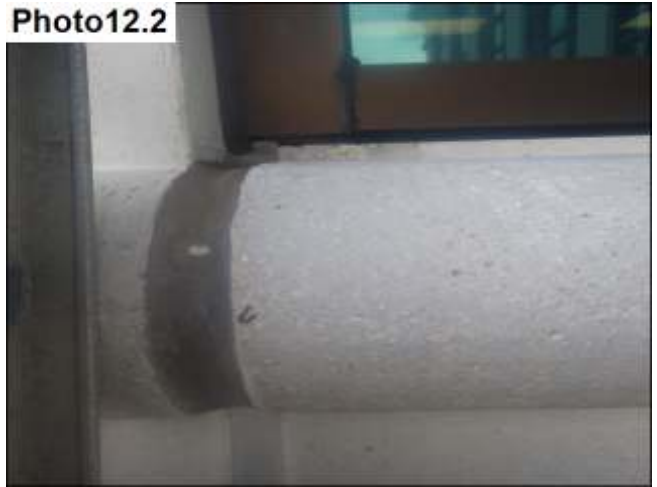
Photo12.2

The sides/corners of the windows channel water at the expansion joints at the front and back entrances (East and West sides) directly onto the joint causing water entry into the building envelope.

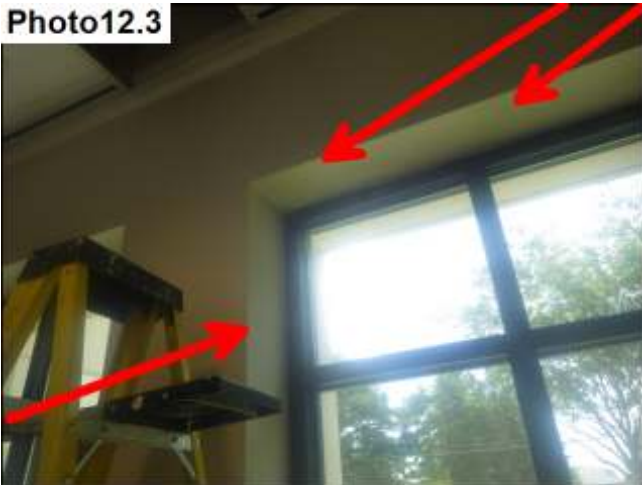
Photo12.3

Water damage from leaking at the left upper (West) side window headers along the hall

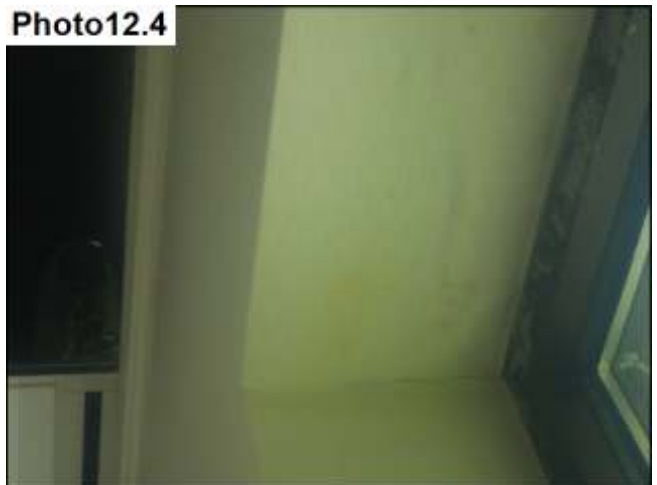
Photo12.4

Water damage from leaking at the front wall left (West) side windows along the hall.

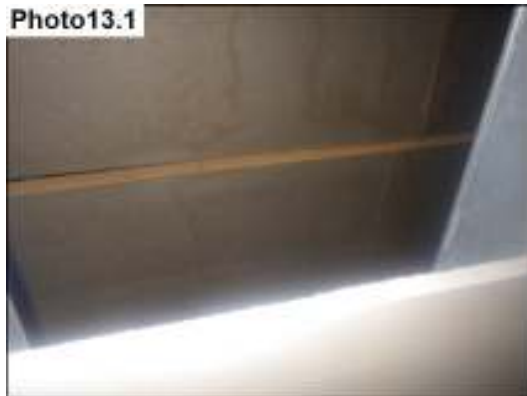
Water stains and damage noted at the back (East) right side upper wall in attic from window leak

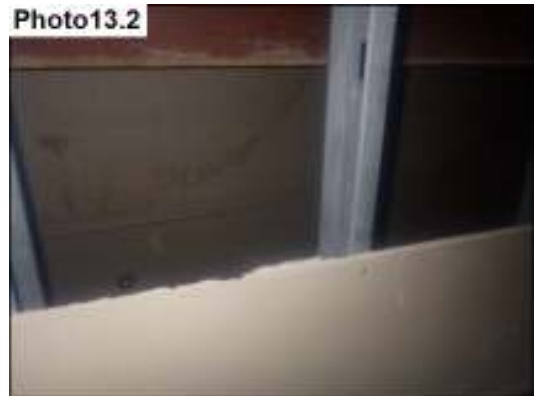
Water stains and damage noted at the back (East) right side upper wall in attic from window leak.

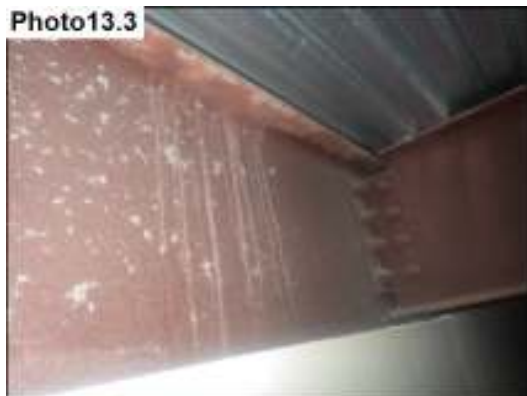
Water stains noted at the front (West) left side upper wall in plenum space from window leaks.

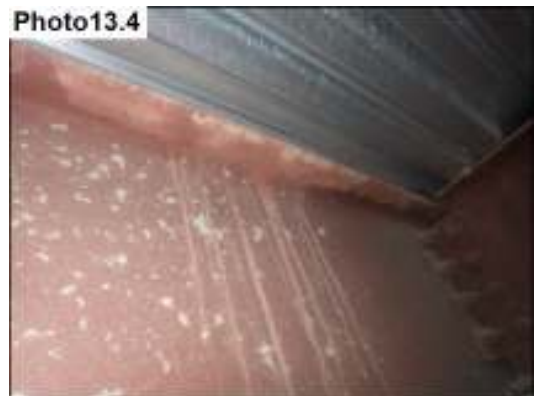
Water stains noted at the front (West) left side upper wall in plenum space from window leaks.

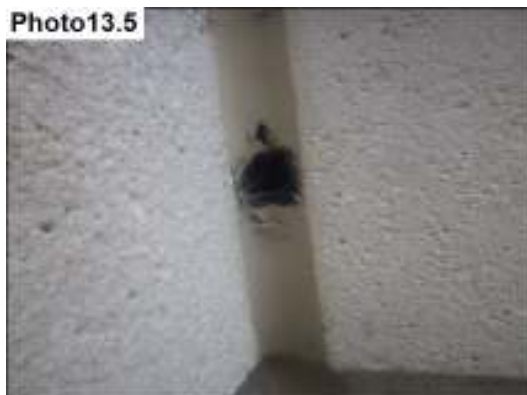
Sealant Failure Repair.

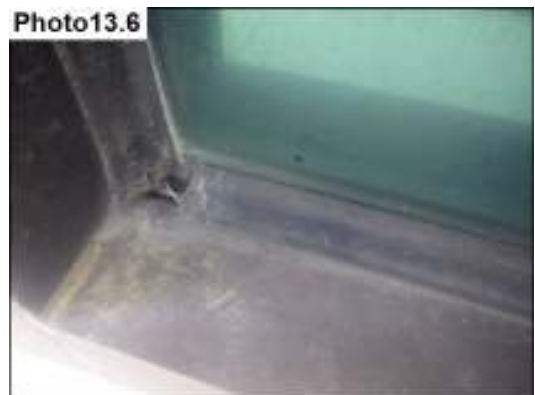
Gasket failure at the exterior side of the windows.

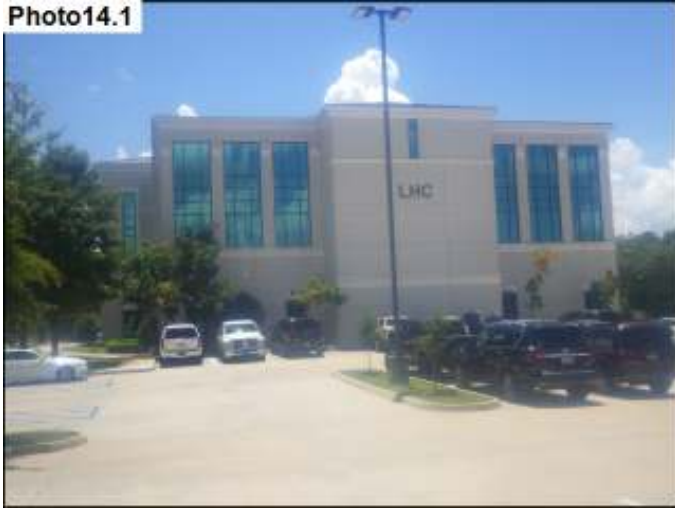
Photo14.1

The only leak noted on the East side of the building was at the inside corner of office 209J.

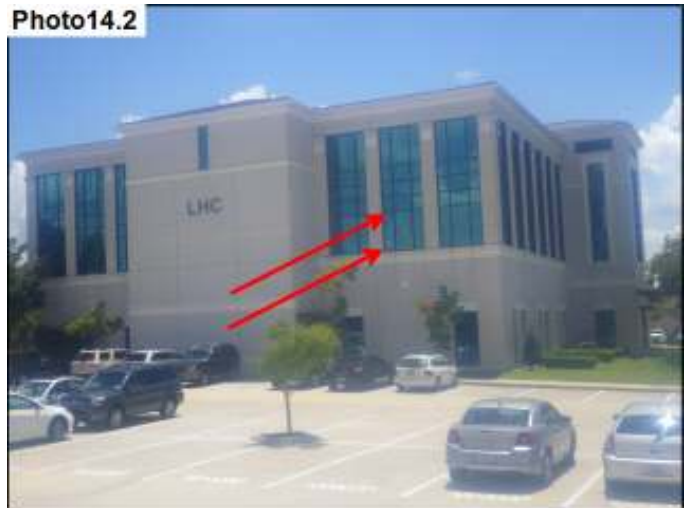
Photo14.2

The West side windows did not have any actively leaking windows or walls.

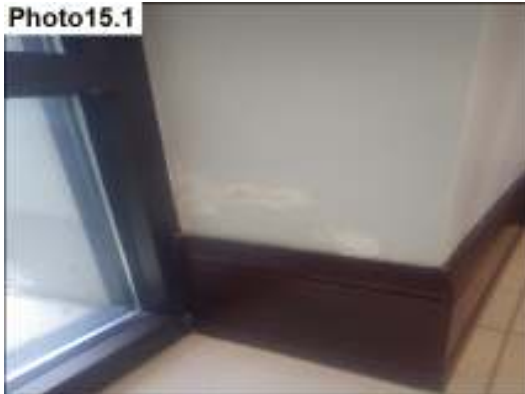
Minor water damage at the lower Back entrance windows

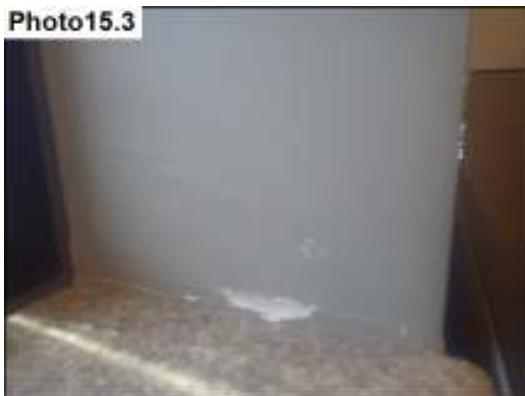
Small area of water damage at the side wall of the second floor office space 212F (Alex Calomb).

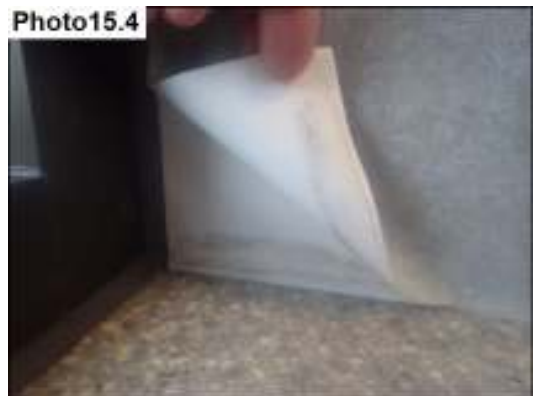
Upstairs break room water damaged wall with apparent microbial growth; correct and repair

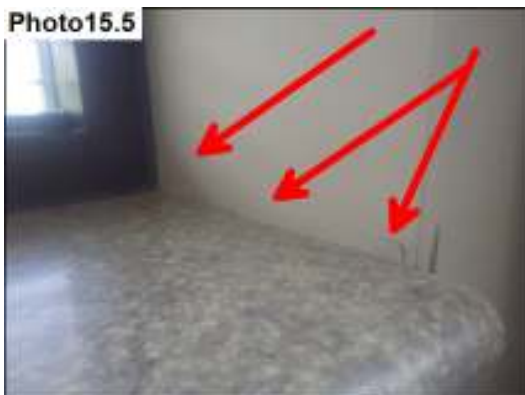
Water stains and damage is noted at the second floor window likely due to condensation.

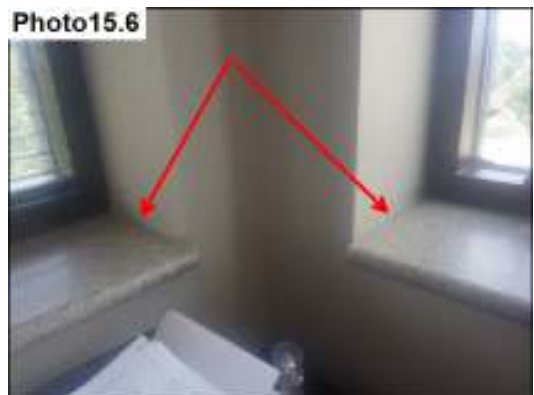
Water stains and damage is noted at the second floor window likely due to condensation.
