Bayou State Inspections

Moisture Inspection Report

308 Jacob B Loop
Alexandria, LA

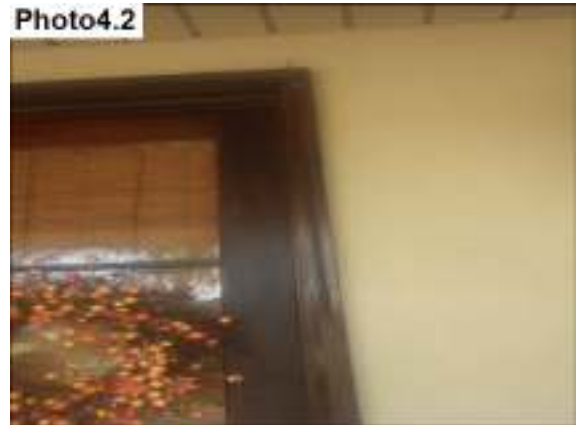
The front window lacks head flashing and sealant joints.

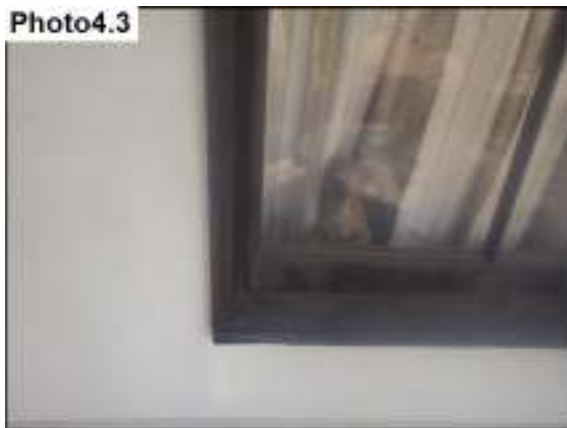
The front window lacks head flashing and sealant joints.

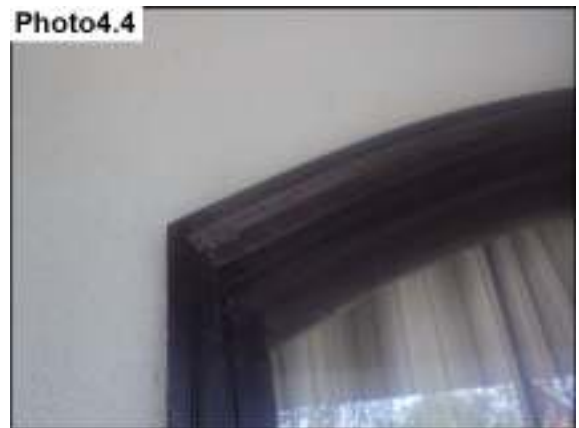
The front door lacks head flashing and sealant joints.

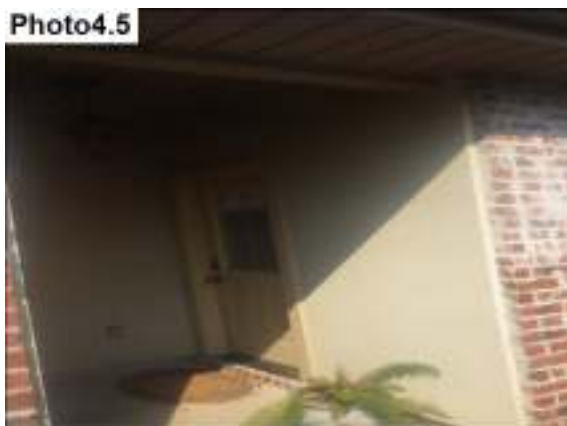
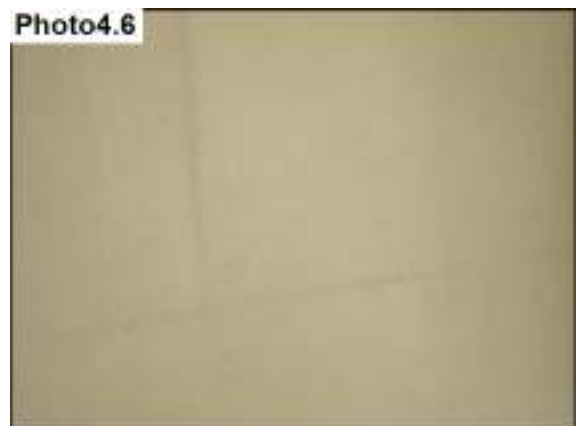
Lines are noted in the stucco wall due to a thin layer of base coat. These lines are the foam boards.

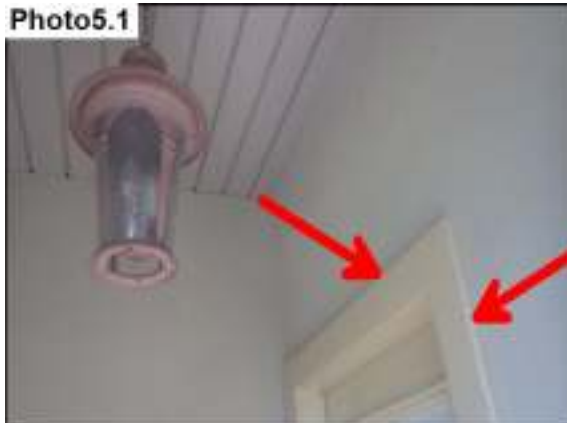
The Side house entrance door lacks head flashing and sealant joints.

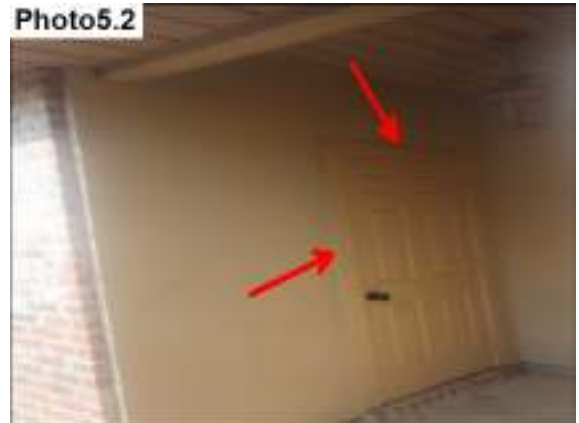
The Side garage door lacks head flashing and sealant joints.

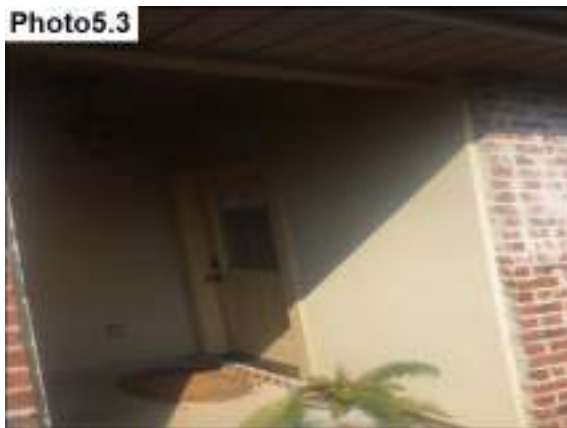
The Side house entrance door lacks head flashing and sealant joints.

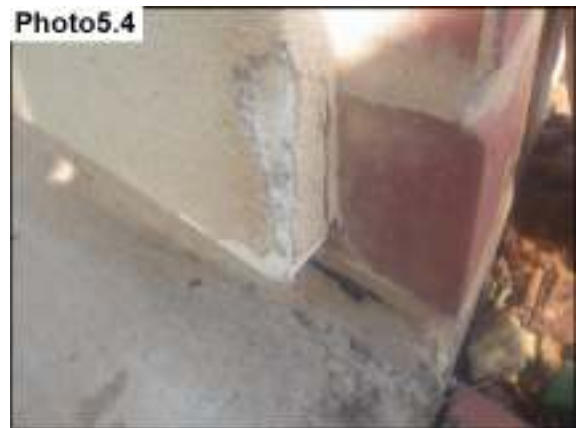
Miscellaneous	Yes	No	N/A	Comments
Evidence Of Sprinkler Overspray		X		
Gutters Clean & Functioning	X			
Down Spout Fasteners Sealed	X			
Cracks Or Impact Damage	X			Minor Impact damage is noted at the bottom right corner of the front porch wall.
Delaminating At Foam / Substrate		X		
Exterior Evidence Of Pest Infestation		X		
Adequate Slope Of Grade Away	X			
Crawlspace Inspection Made		X		
Property Located Near Body of Water If Yes, Describe		X

Minor impact damage at the lower right front wall bottom corner.

1. The lack of head flashing at the window and doors has not resulted in adverse conditions nor has any damage resulted from this missing detail.
2. Impact damage with minor substrate damage is not at the bottom corners of the system; this will require repairs by a qualified Stucco Contractor.
3. The foam insulation boards that make up the system can be seen due to either a very thin base coat or improper deflection when installed. BSI recommends re-coating the wall and adding an elastimeric coating to correct the system. BSI recommends repairs by a qualified Stucco Contractor.
4. Cost for these repairs can vary a great deal from area to area and even from contractor to contractor. BSI estimates these repairs to cost between \$1800-\$2600.

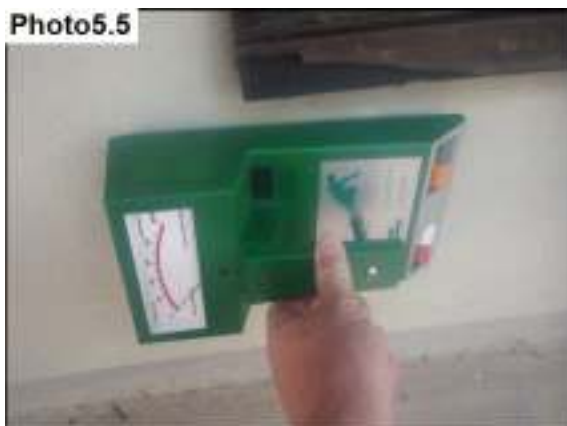
Front window moisture meter left side.

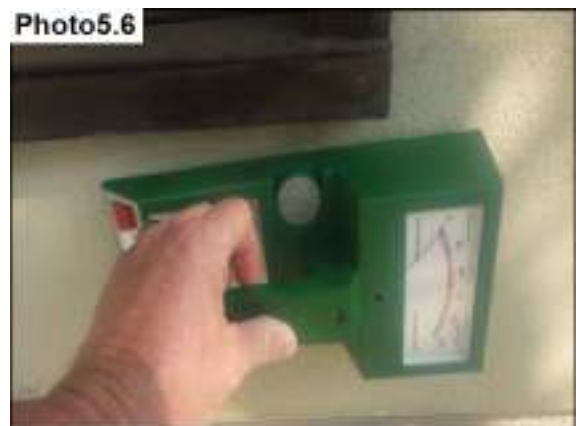
Front window moisture meter right side.
