Real Estate Inspection Report

The Grand Am Star 16 5996 Zebulon Road Macon, GA 31210

Prepared for: VSS-Southern Theatres, LLC 5996 Zebulon Road

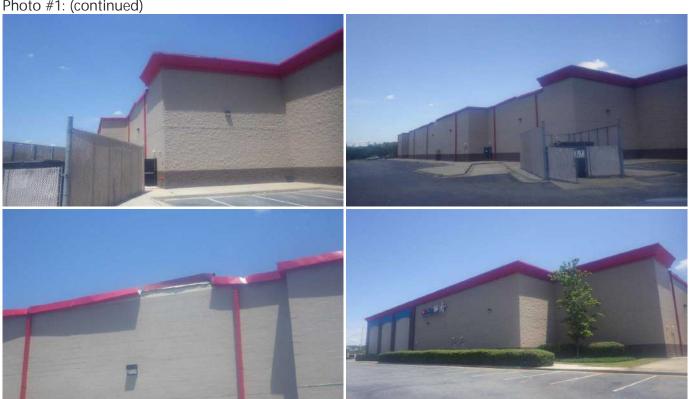
Photo #1: (continued)

Photo #1: Elevation photos.

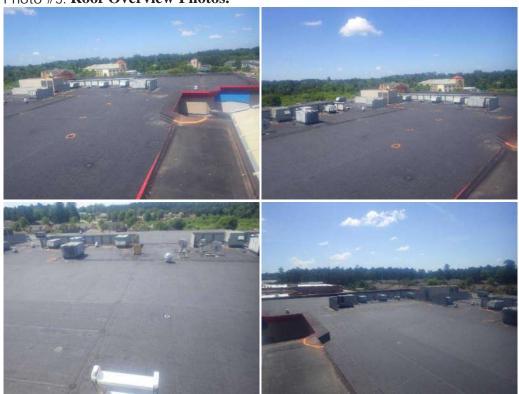
Photo #5: Roof Overview Photos.

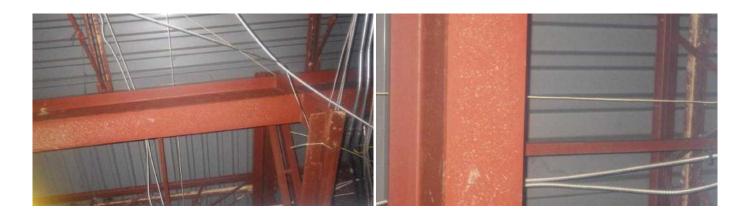
Photo #6: (continued)

Photo #6: Water entry at Second Floor Mezzanine Area

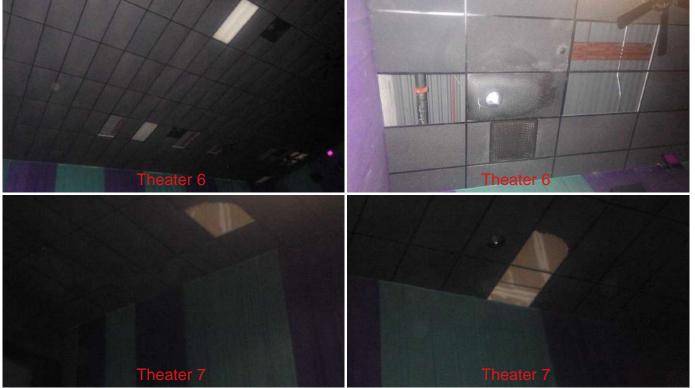
Photo #7: Water damage and entry inside Theatre

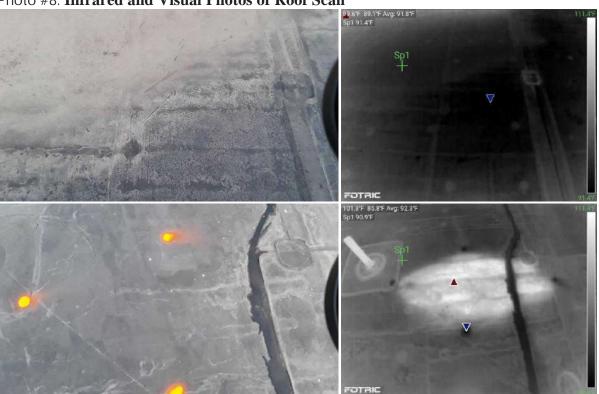
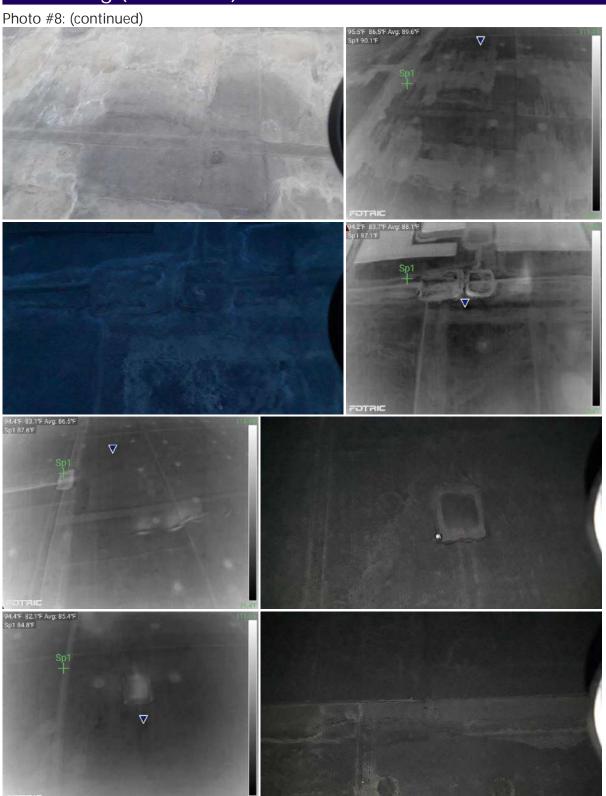
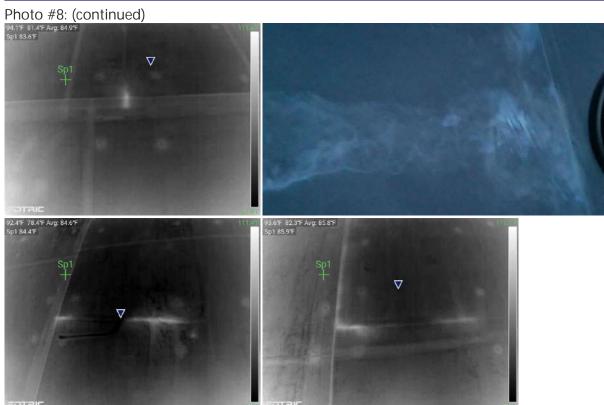
Photo #8: Infrared and Visual Photos of Roof Scan

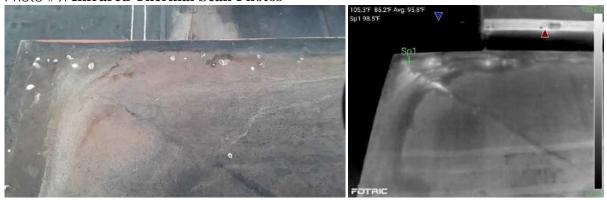
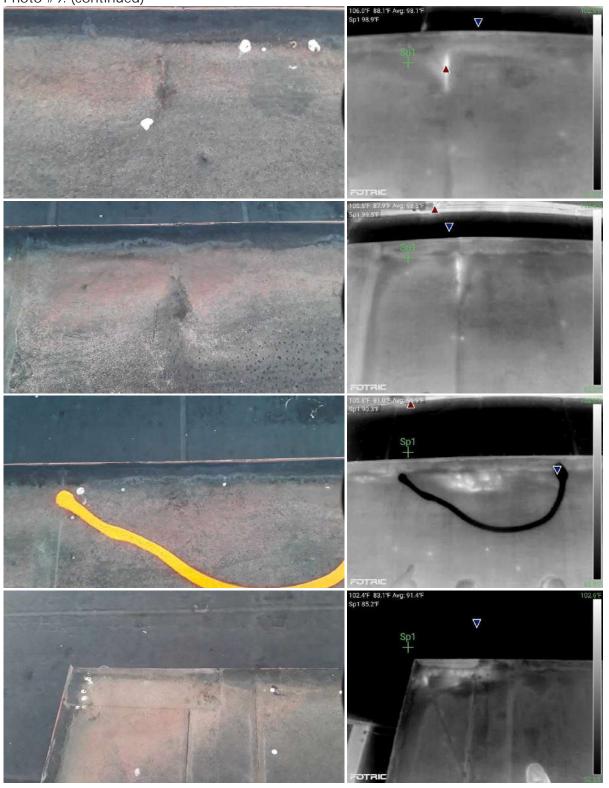
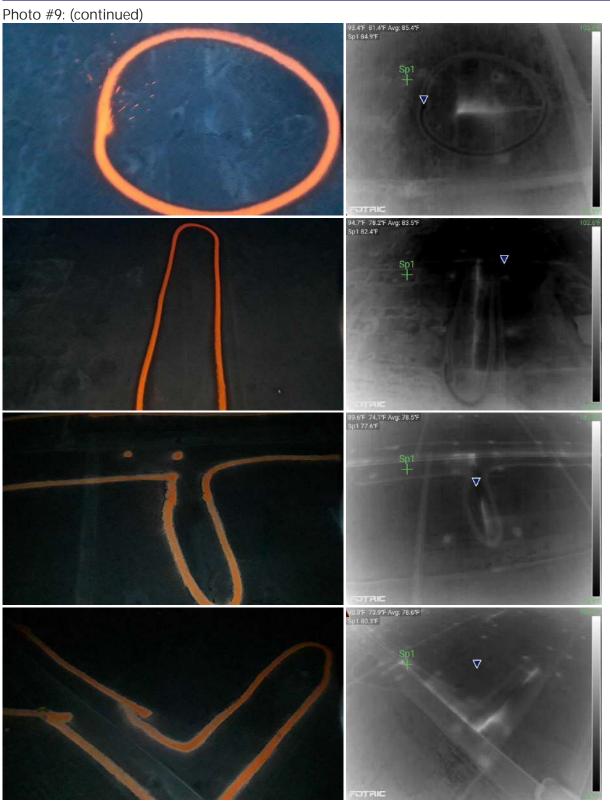
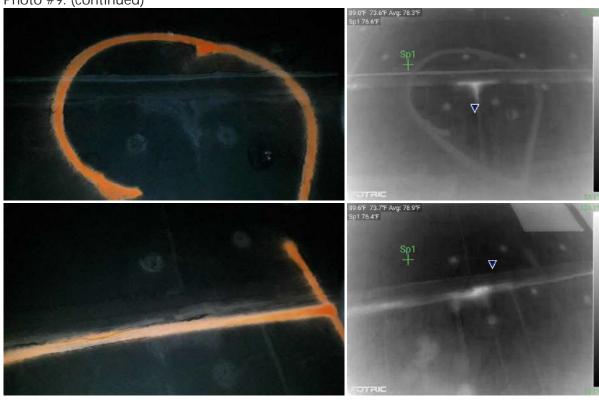
Photo #9: Infrared Thermal Scan Photos

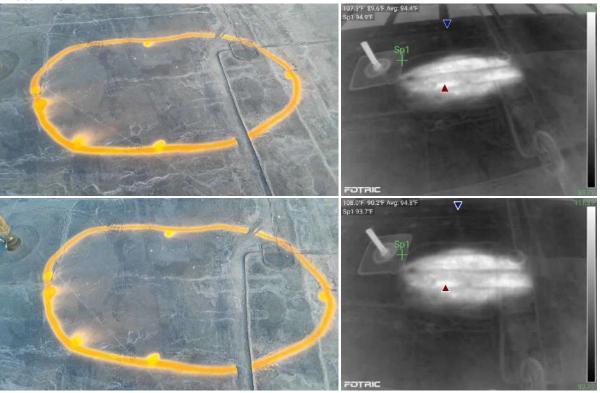
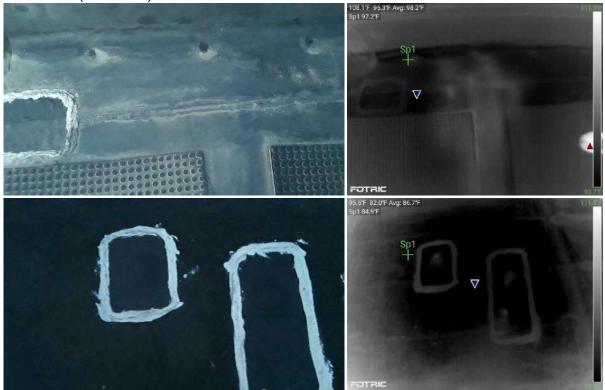
Photo #10: Infrared Thermal Scan Photos
