Qualitative Infrared Thermographic Survey of Electrical Switchgear

**Chase Tower
Lafayette, LA**

October 4 & 5, 2021

BSI PROJECT # 21-1004-JY

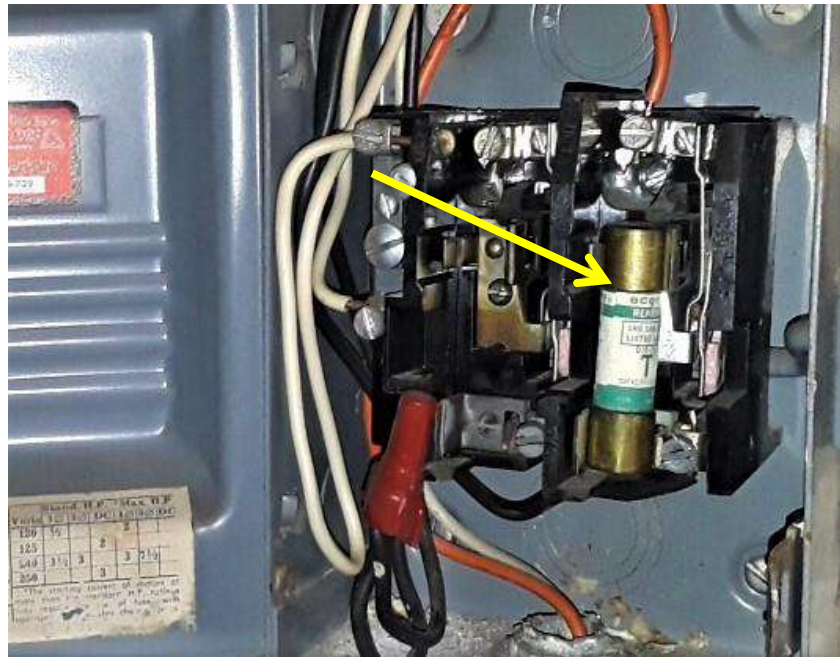
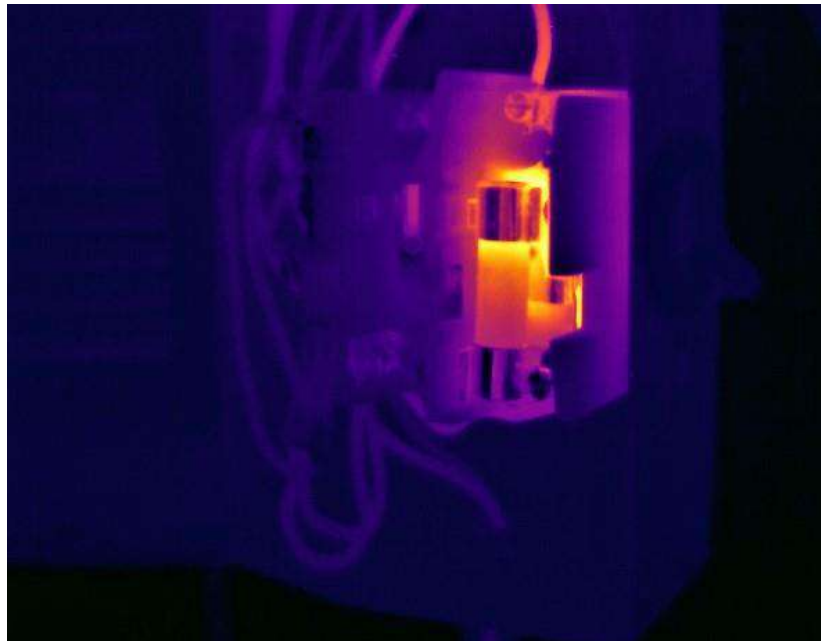
**THERMOGRAPHIC
REPORT # 1**

Severity - Alert

Fuse and Fuse Clip heating as indicated, Phase B, Load Side.

Clean/Tighten Fuse Clip Connection. Replace Fuse Block if necessary.

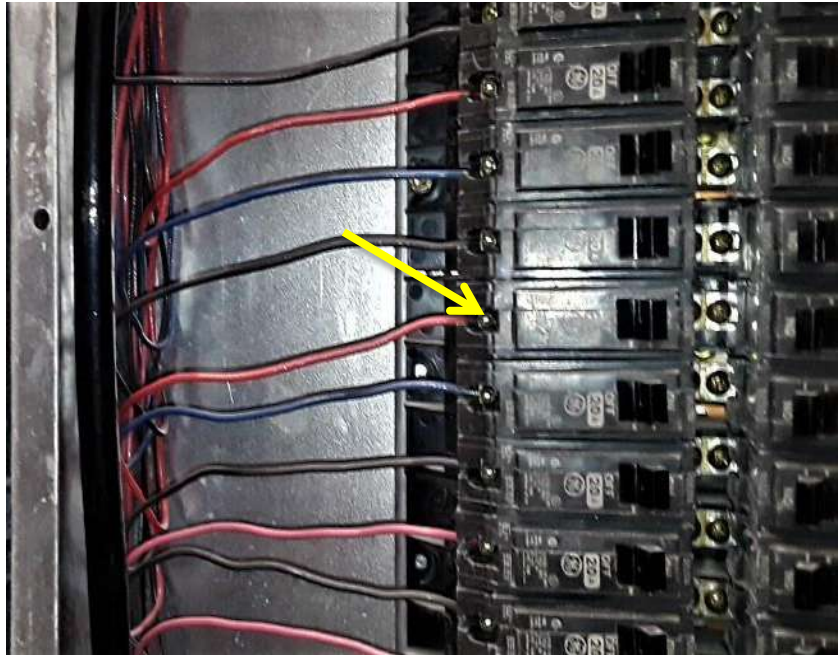
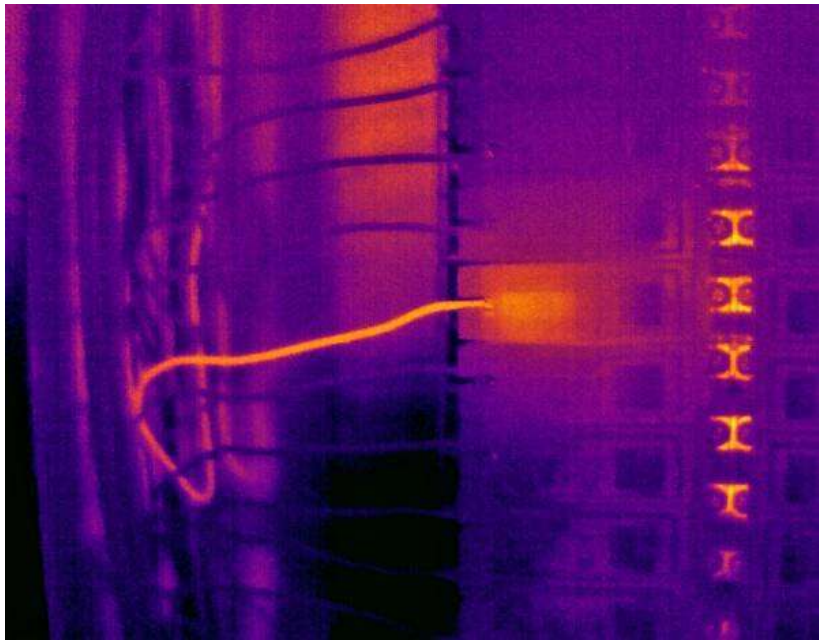
**THERMOGRAPHIC
REPORT # 2**

Severity - Minor

Description:
Breaker and Wire heating as Indicated, Phase A, Line Side.

Recommendations:
Clean/Tighten Lug Connection. Repair/Replace as necessary.

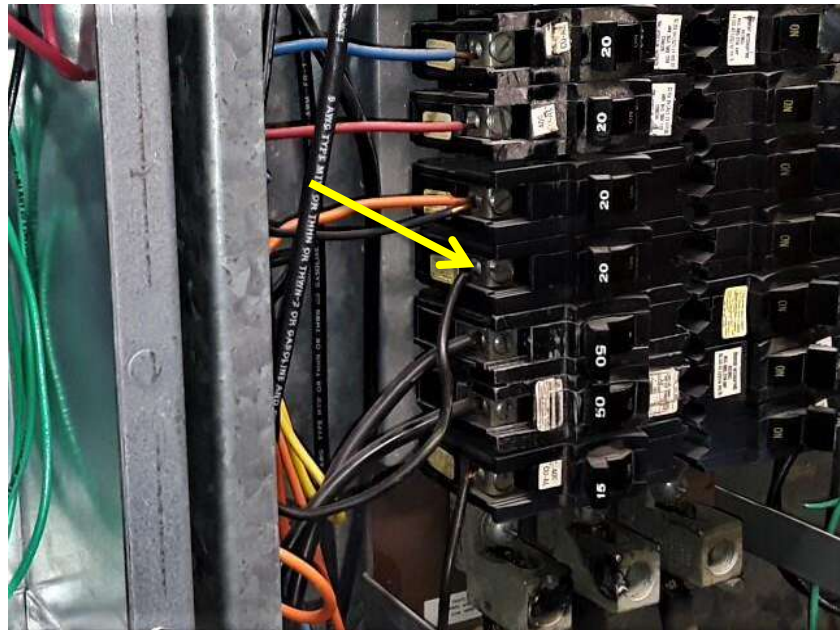
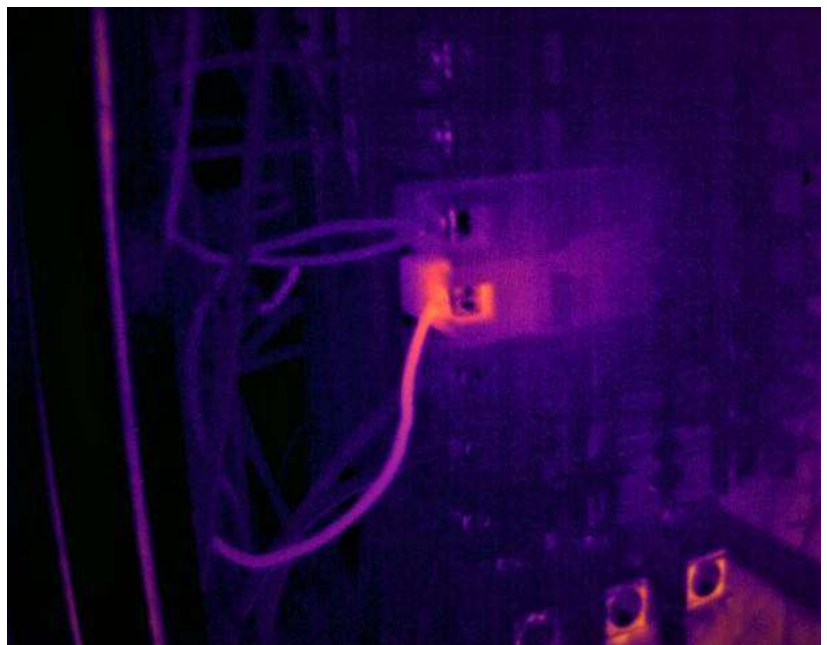
THERMOGRAPHIC REPORT # 3

Severity - Minor

Breaker and Wire heating as indicated, Phase C, Line Side.

Clean/Tighten Lug Connection. Repair/Replace as necessary.

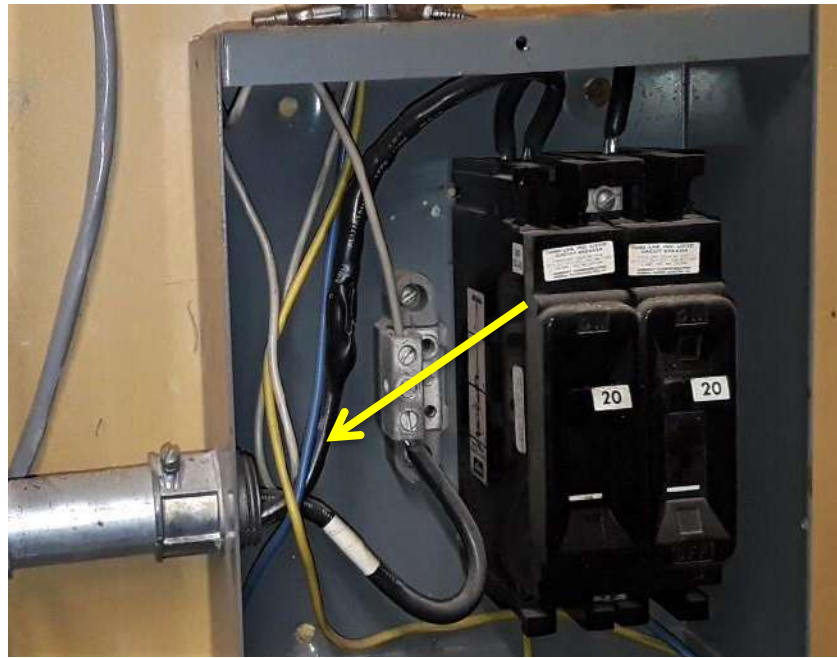
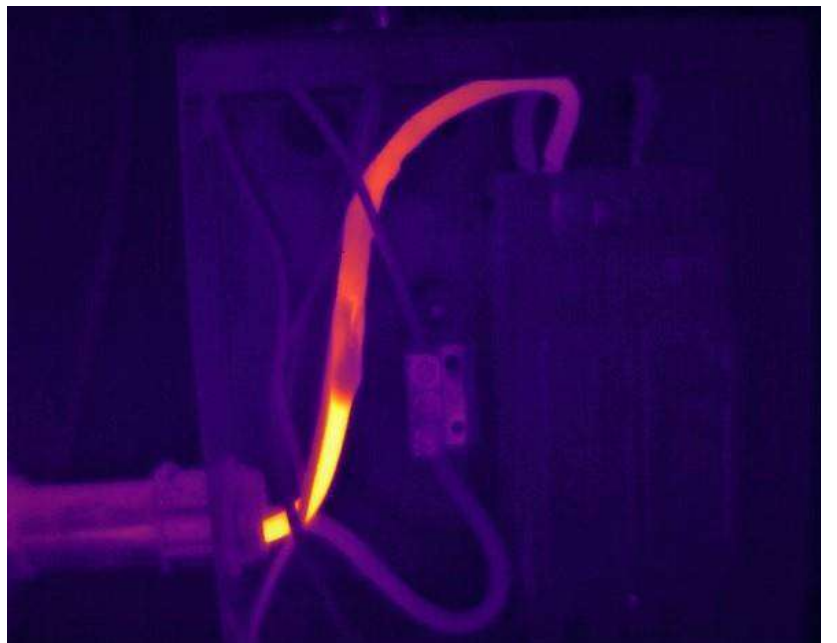
**THERMOGRAPHIC
REPORT # 4**

Severity - Alert

Wire heating as indicated, Phase A, Load Side.

Reconnect Wire Splice. Replace Wire as necessary.

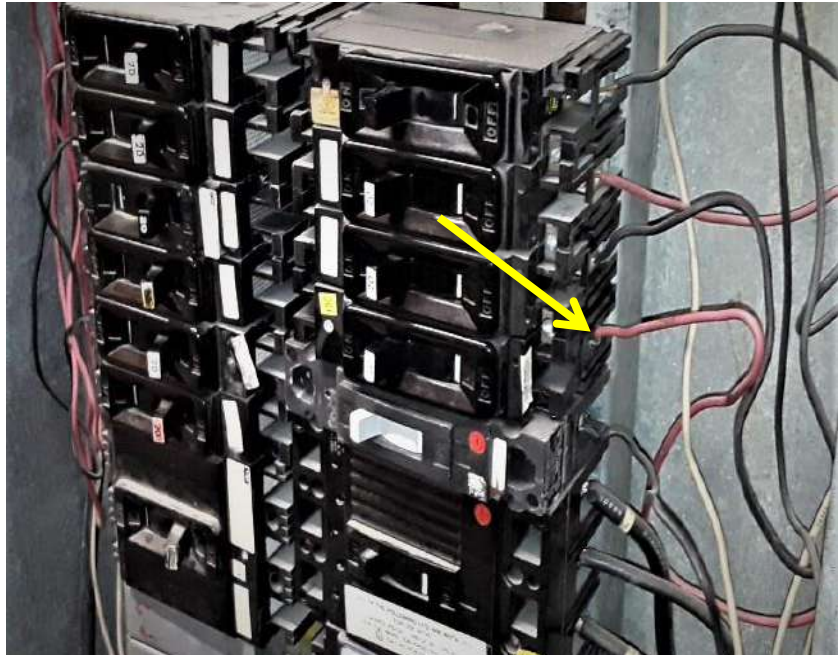
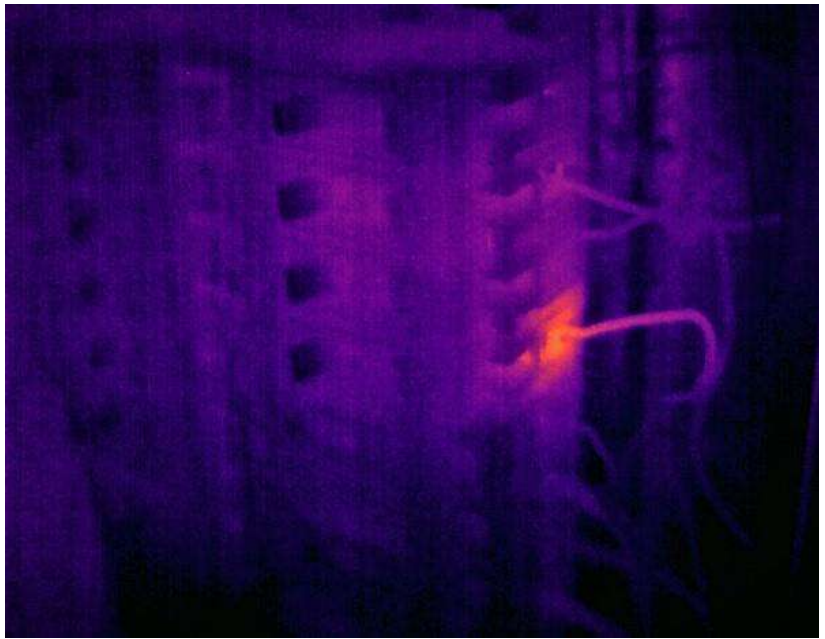
THERMOGRAPHIC REPORT # 5

Severity – Minor

Description:
Breaker Lug heating as indicated, Phase A, Line Side.

Recommendations:
Clean/Tighten Connection. Repair/Replace as necessary.

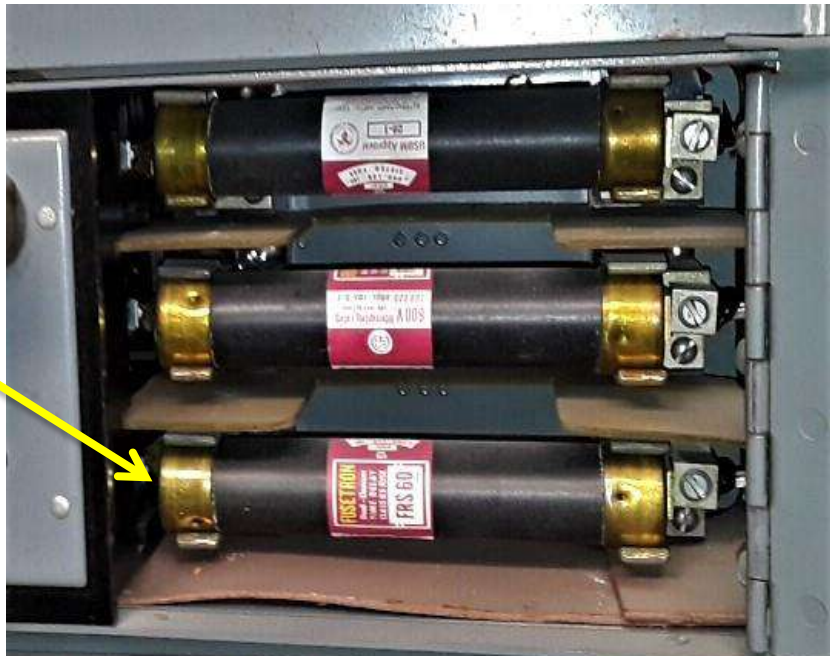
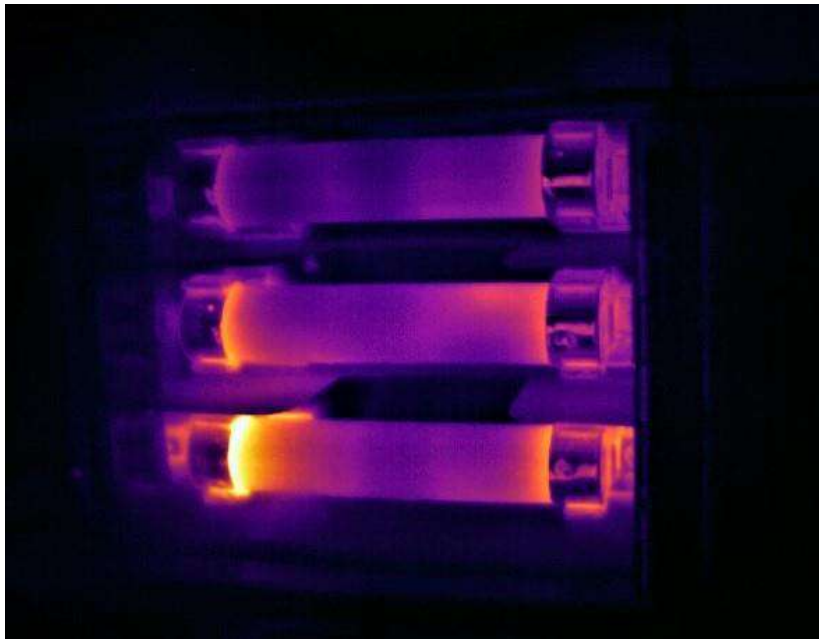
THERMOGRAPHIC REPORT # 6

Fuse/Fuse Clip heating as indicated, Phase C, Line Side.

Clean/Tighten Fuse Clip connection. Repair/Replace Fuse Block as necessary.

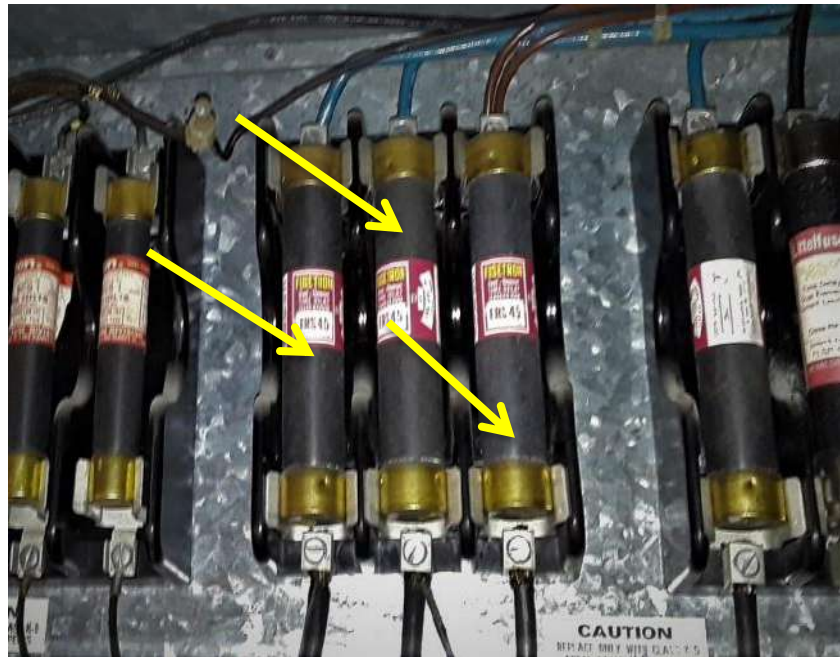
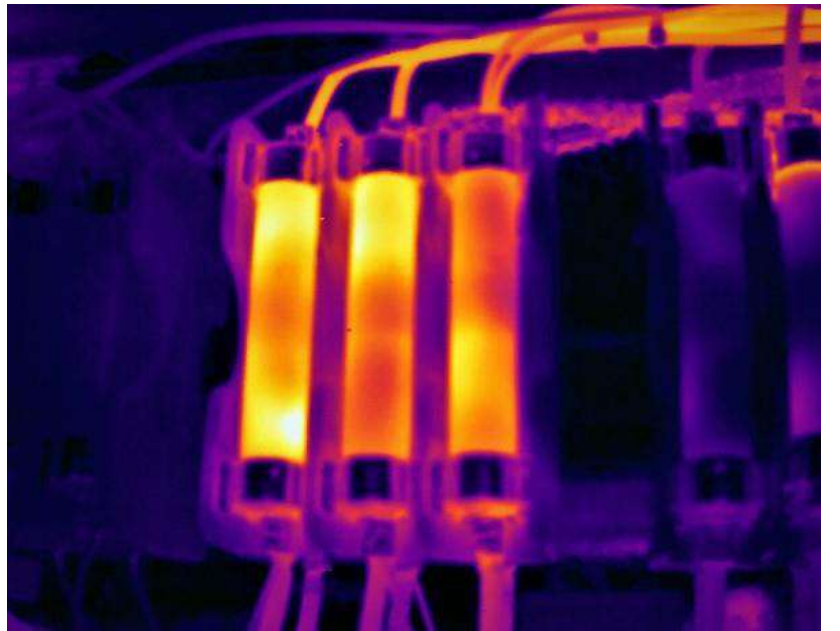
Fuses heating as indicated, Phases A, B, and C, Line and Load Sides.

Clean/Tighten Fuse Connections. Replace Fuses/Fuse Block as necessary.

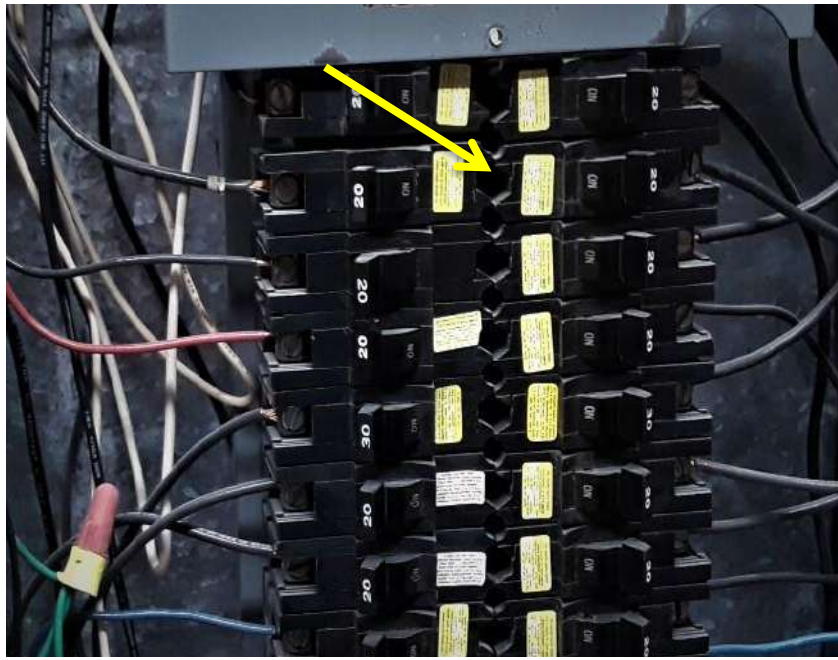
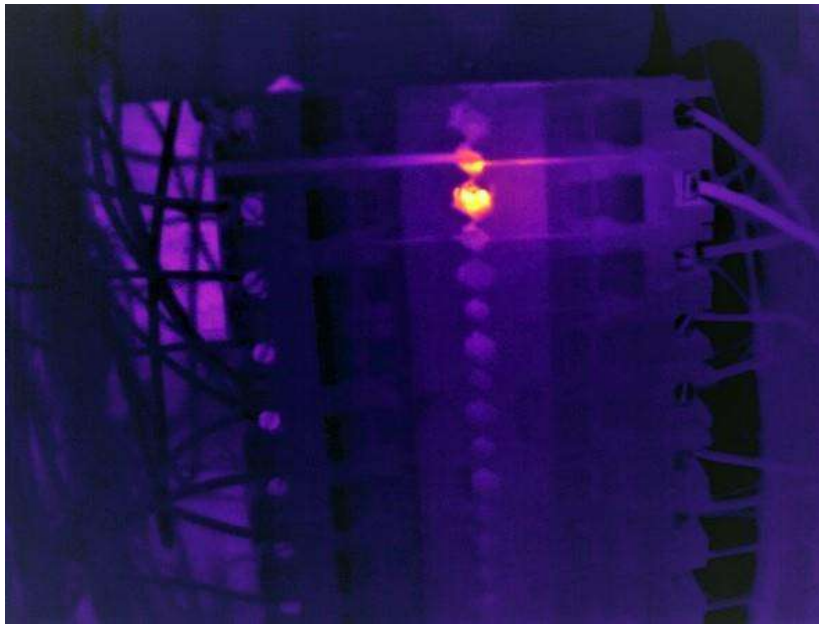
Circuit Breaker Bolt on Connections heating as indicated, Phase B, Line Side.

Clean/Tighten Bolt on Connections between Breakers. Replace Breakers.

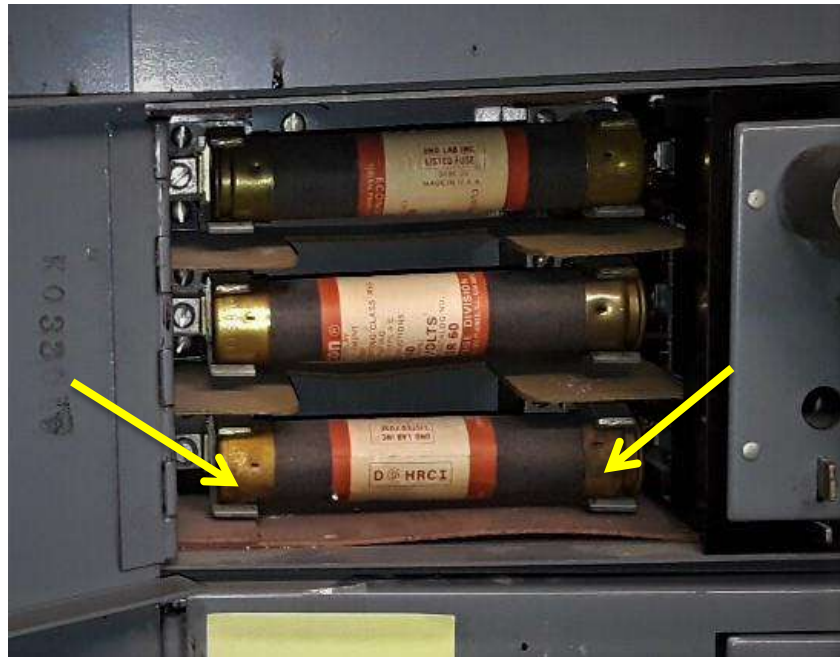
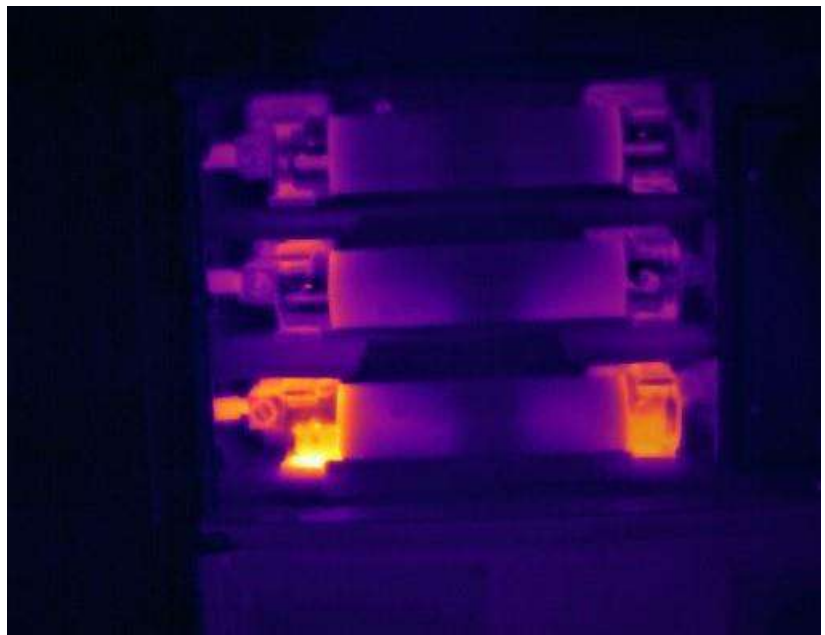
Fuse/Fuse Clip heating as indicated, Phase C, Line and Load Side.

Clean/Tighten Fuse/Fuse Clip. Replace Fuse Block as necessary.

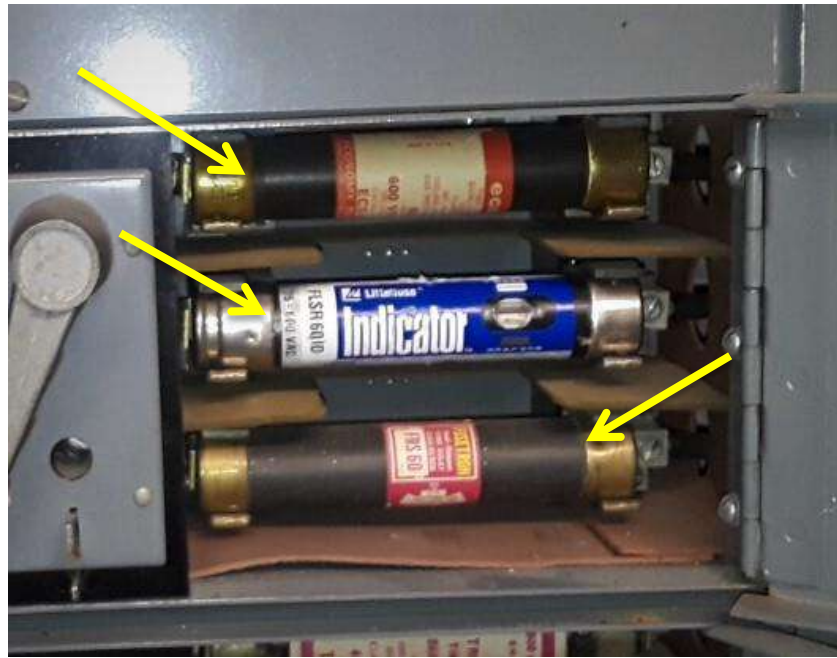
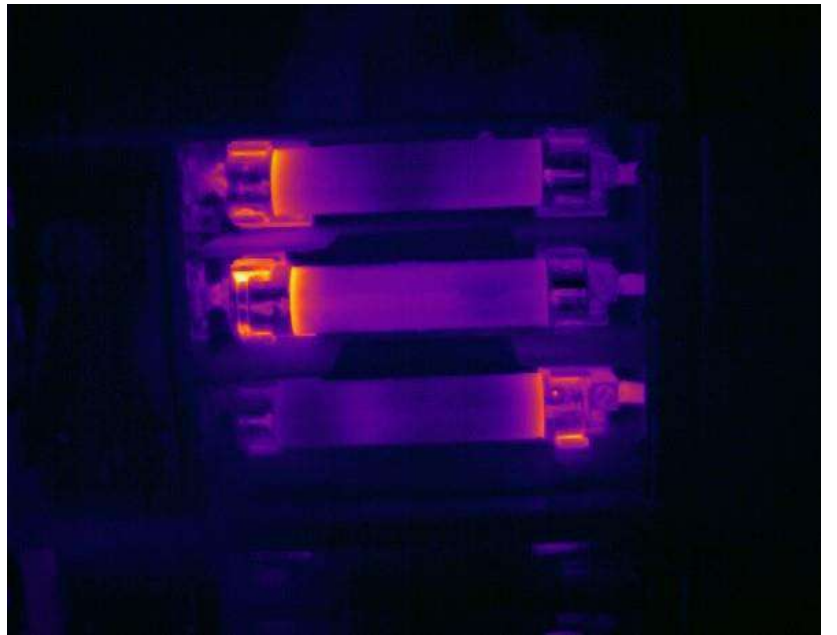
Fuses heating as indicated, Phase A, Line Side, Phase B, Line Side, Phase C, Load Side.

Replace Fuse Block as necessary.

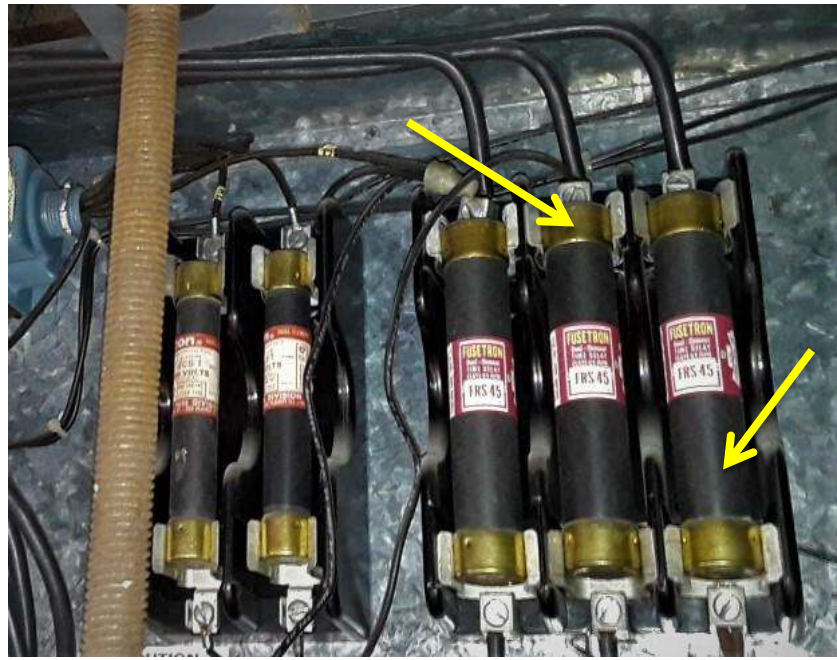
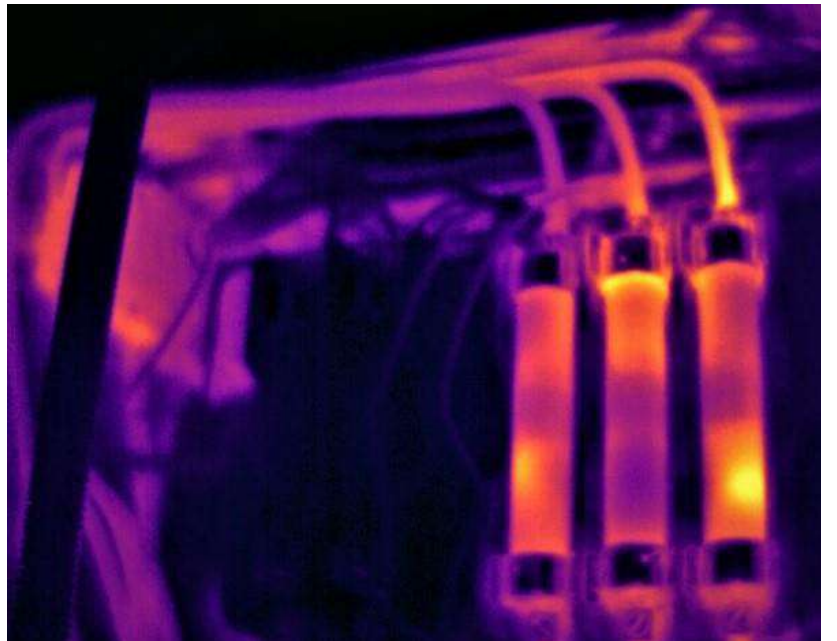
Fuses heating as indicated, Phase B, Line Side, Phase C, Load Side.

Clean/Tighten Fuses/Fuse Clips. Replace Fuse Block as necessary.

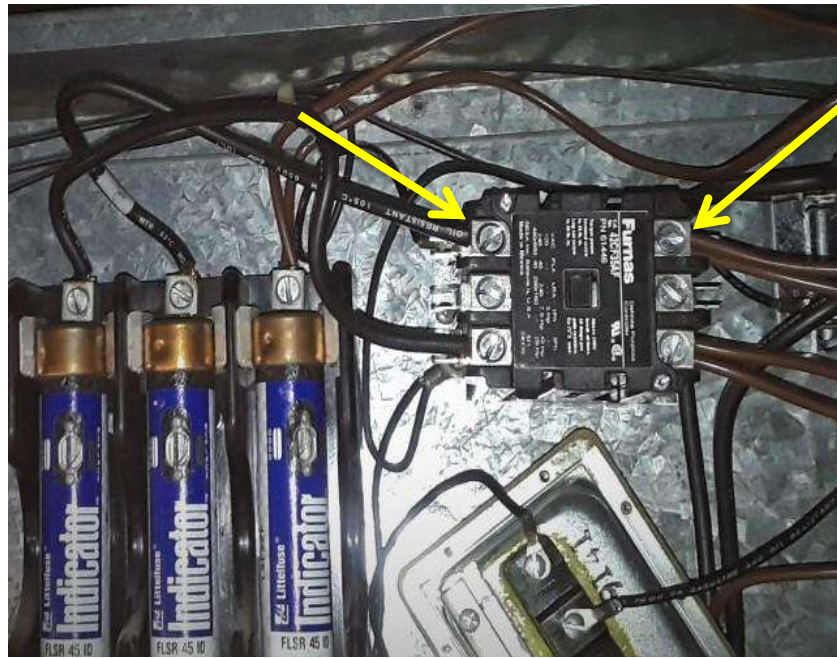
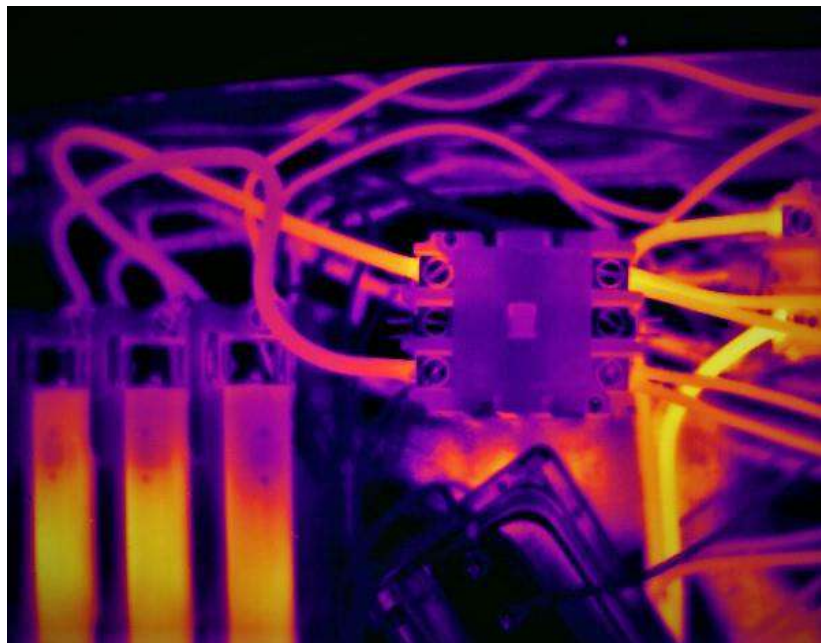
Wire heating as indicated, Phase A, Line and Load Sides.

Re-wire Contactor. Replace as necessary.

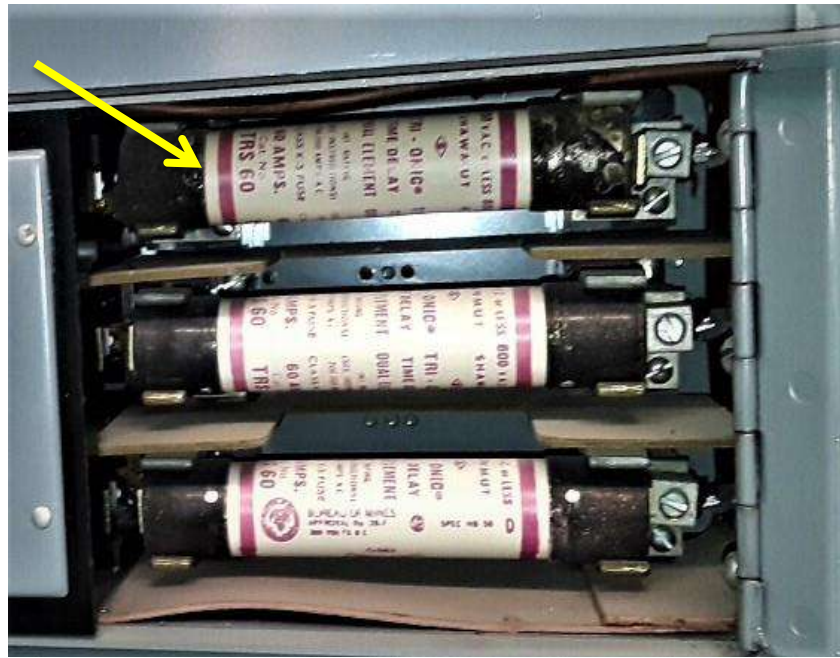
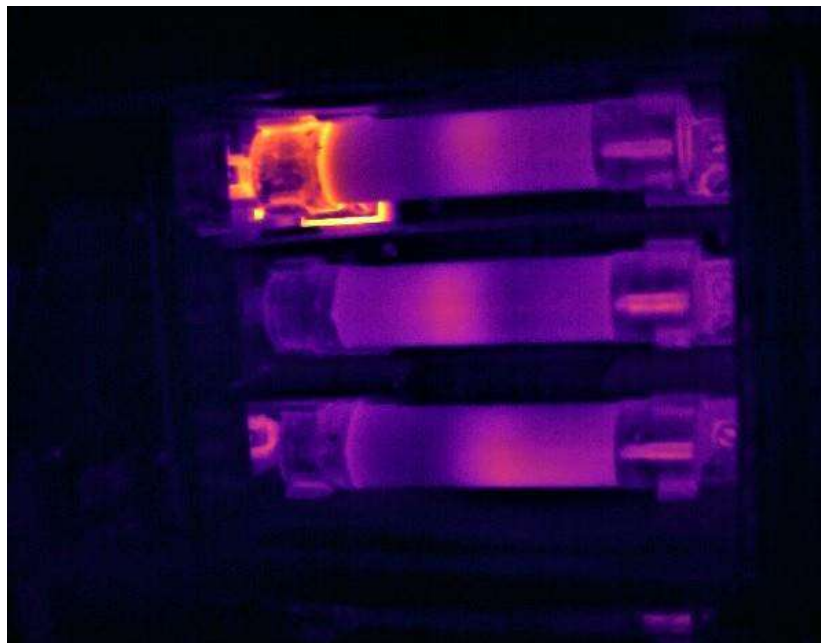
Fuse/Fuse Clip heating as indicated, Phase A, Line Side.

Clean/Tighten Fuse/Fuse Clip. Replace Fuse Block as necessary.

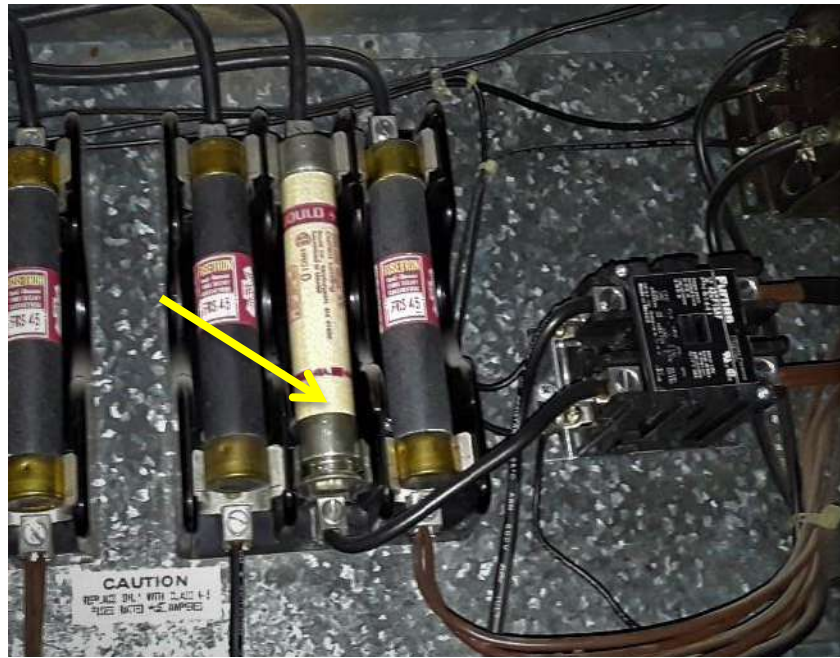
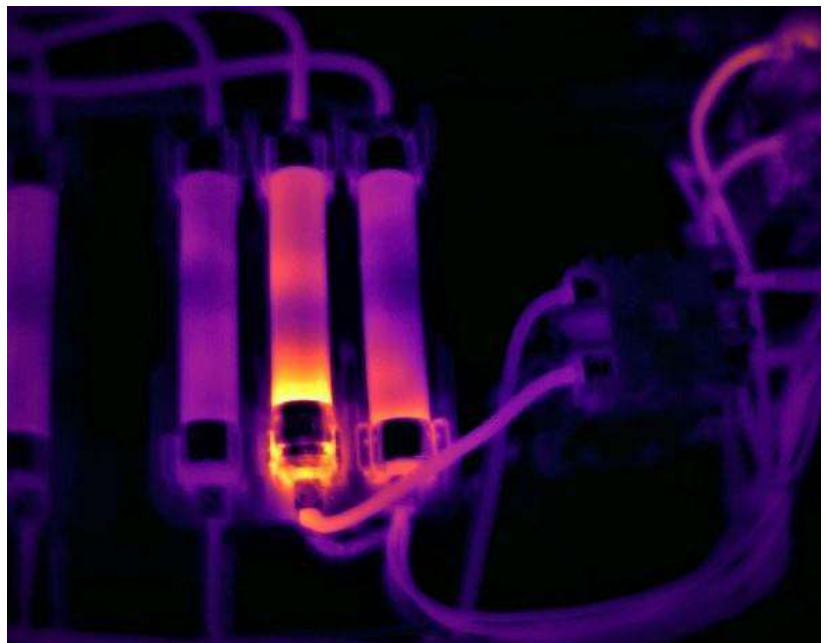
Fuse/Fuse Clip heating as indicated, Phase B, Line Side.

Clean/Tighten Fuse/Fuse Clip. Replace Fuse Block as necessary.

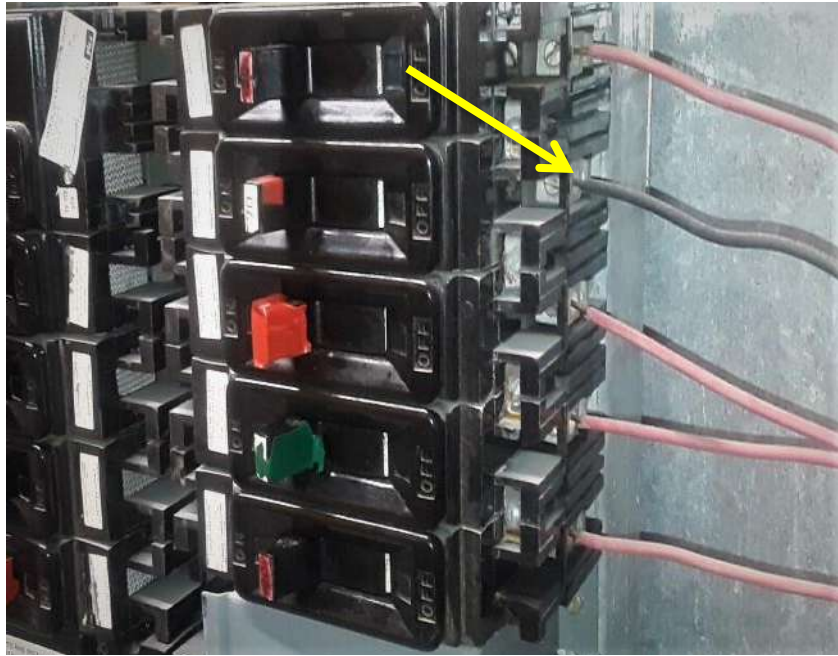
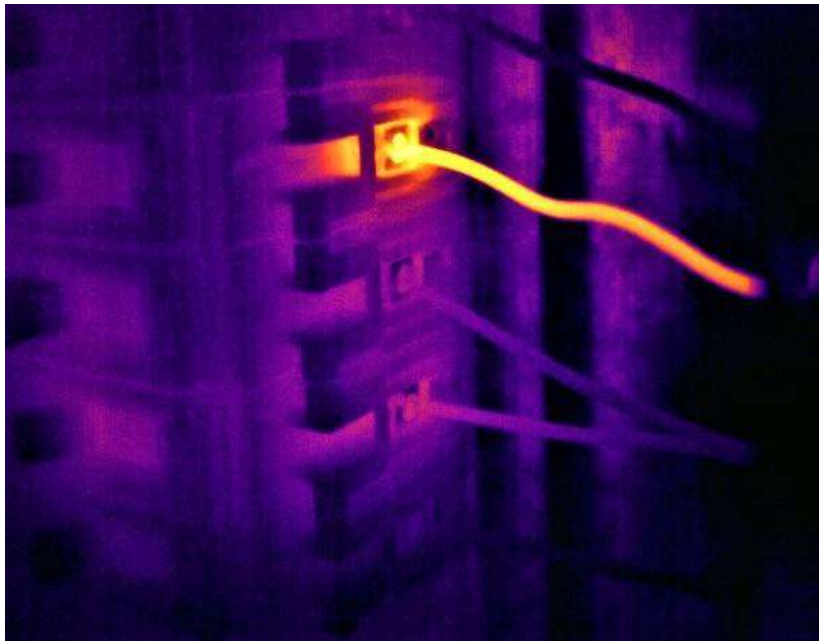
Wire heating as indicated. Circuit Overloaded, Phase B, Line Side.

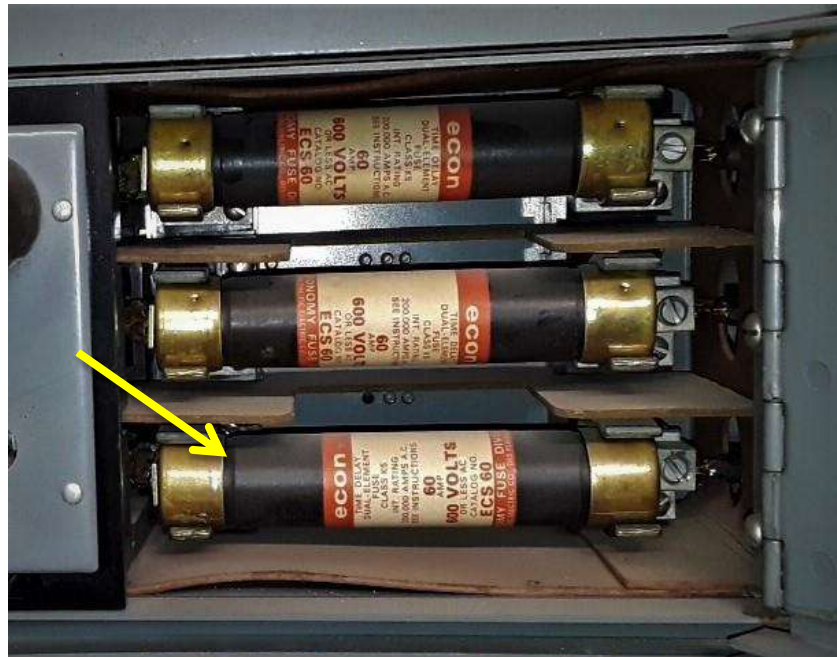
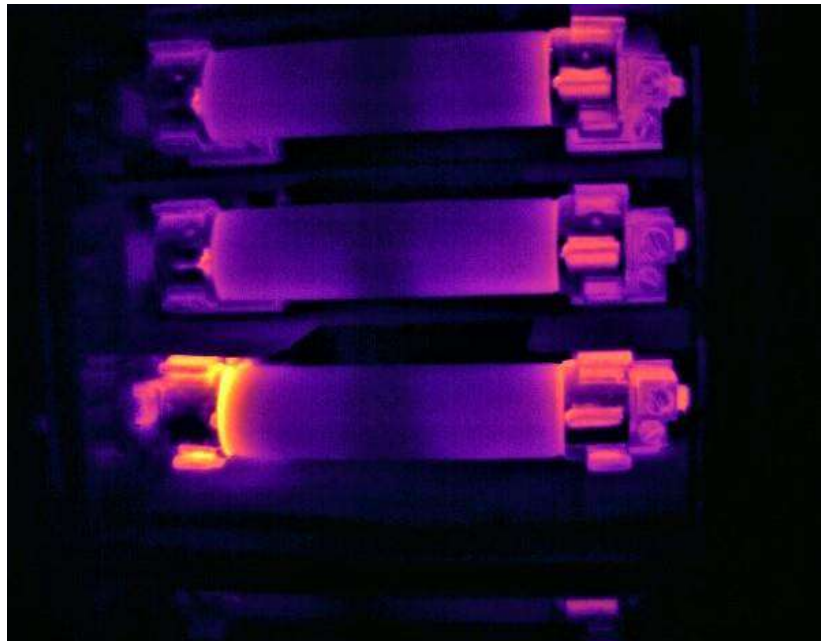
Fuse/Fuse Clip heating as indicated, Phase C, Line Side.

Clean/Tighten Fuse/Fuse Clip. Replace Fuse Block as necessary.

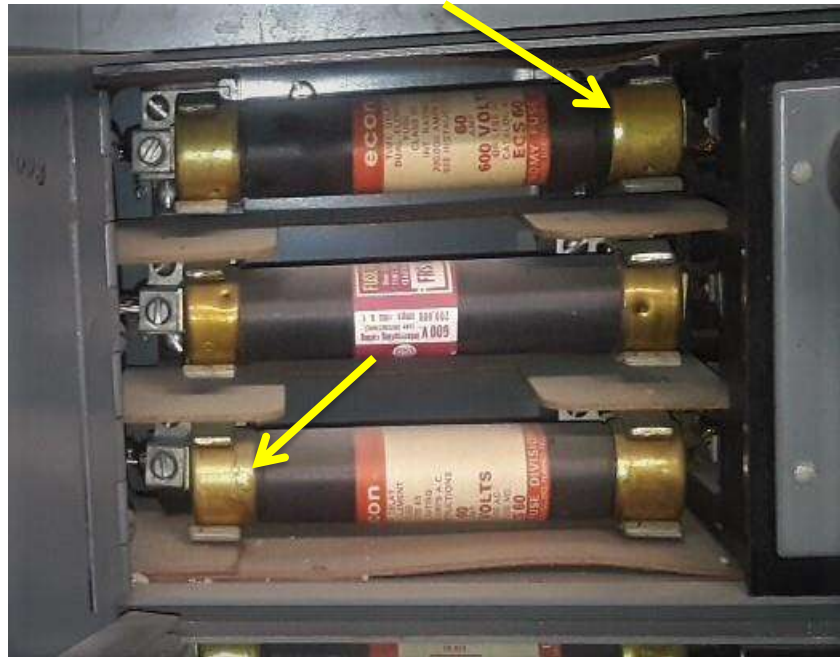
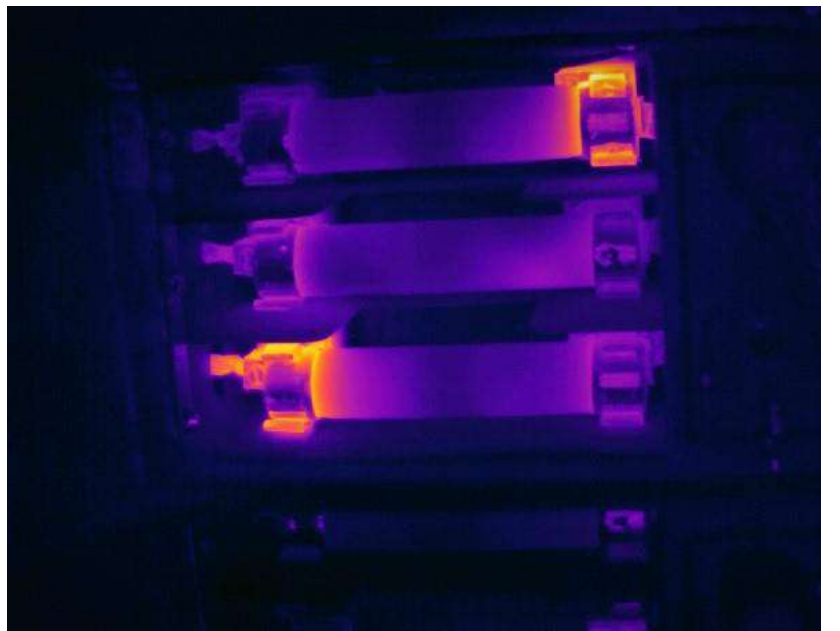
Fuses/Fuse Clips heating as indicated, Phase A, Line Side, Phase C, Load Side.

Clean/Tighten Fuses/Fuse Clips. Replace Fuse Block as necessary.

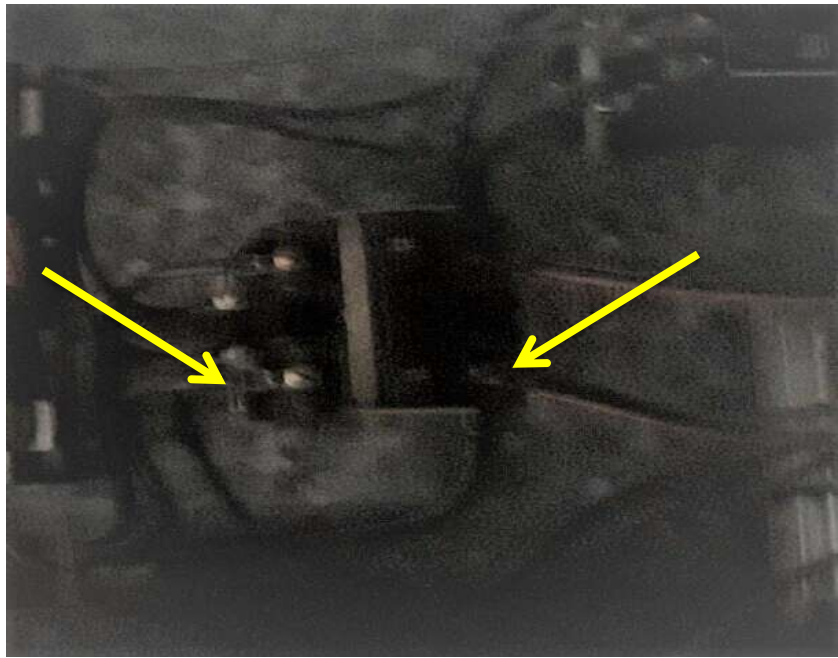
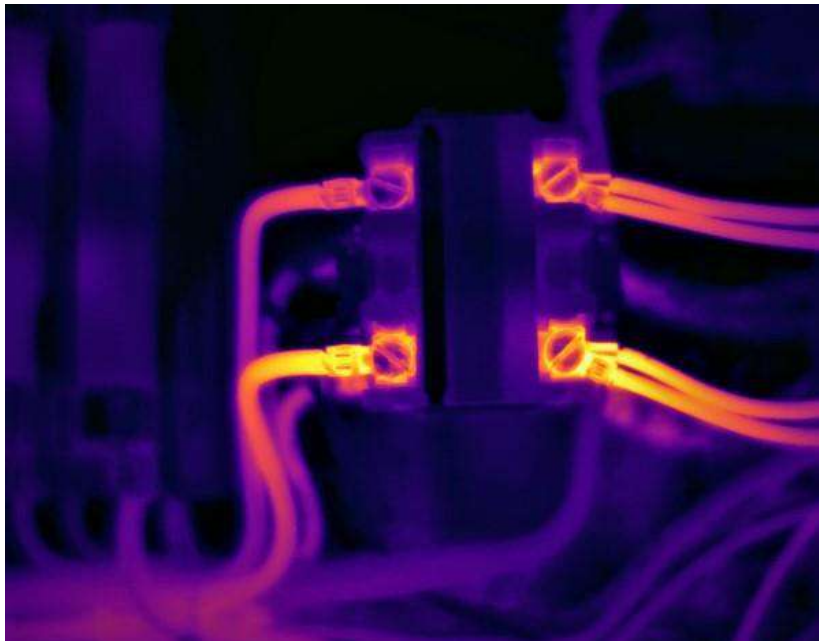
Contactor/Wiring heating as indicated, Line and Load Sides.

Replace and Re-wire Contactor as necessary.

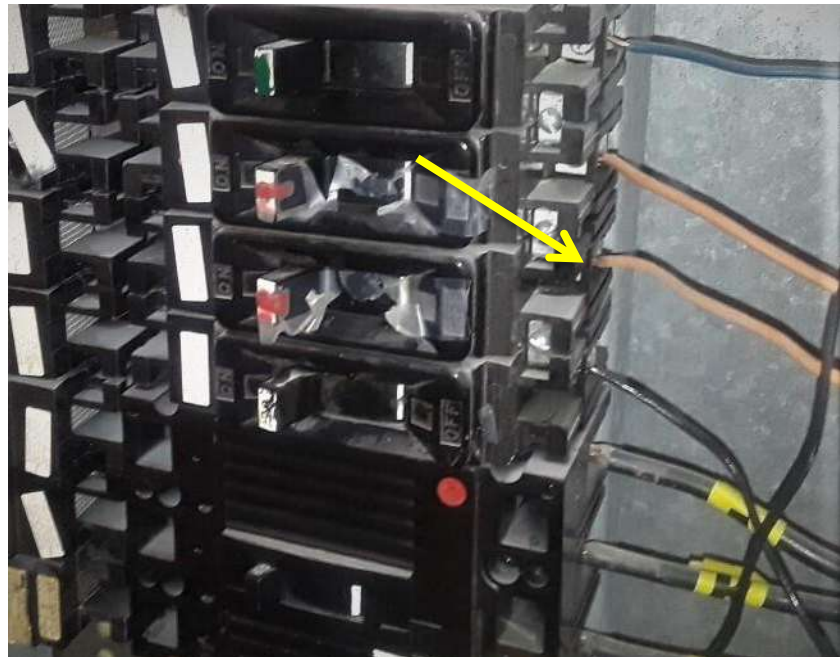
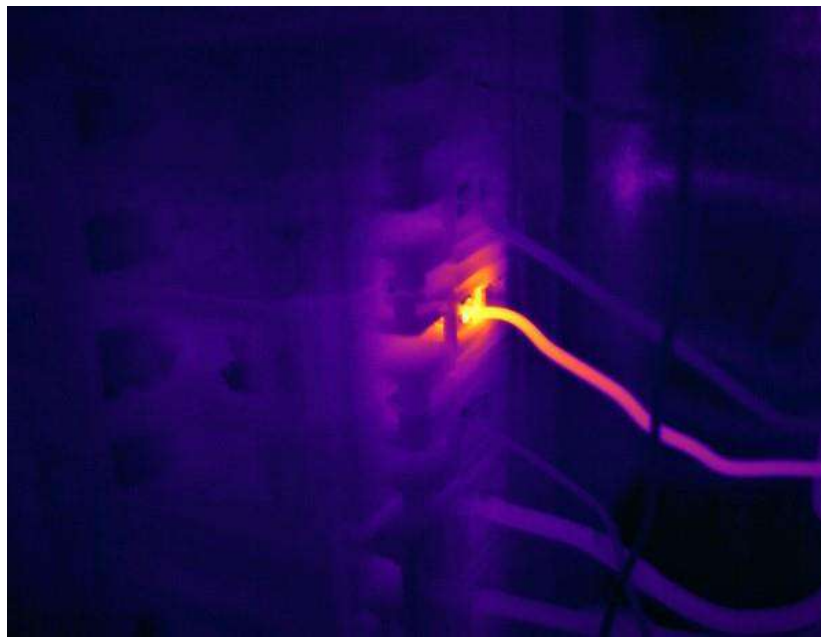
Wire heating as indicated, Phase C, Line Side.

Clean/Tighten Breaker Lug Connection. Replace Breaker as necessary.

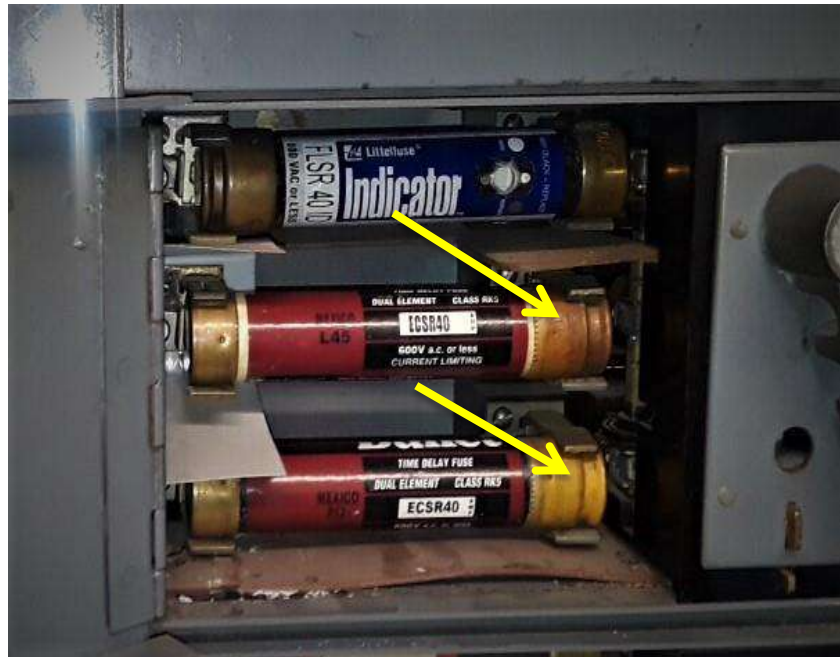
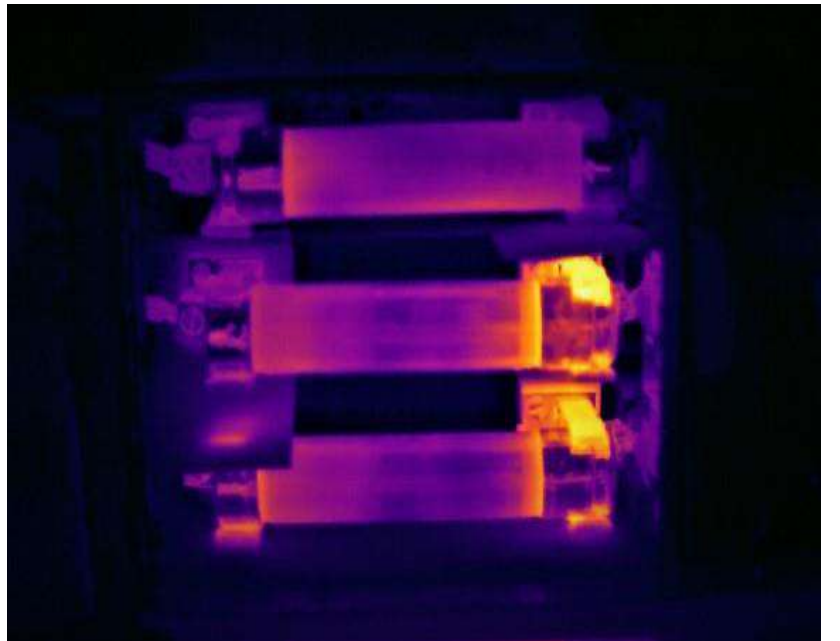
Fuses/Fuse Clips heating as indicated, Phases B and C, Line Sides.

Clean/Tighten Fuses/Fuse Clips. Replace Fuse Block as necessary.
