Qualitative Infrared Thermographic Survey of Electrical Switchgear

**Chase Tower
Lafayette, LA**

October 4 & 5, 2021

BSI PROJECT # 21-1004-JY

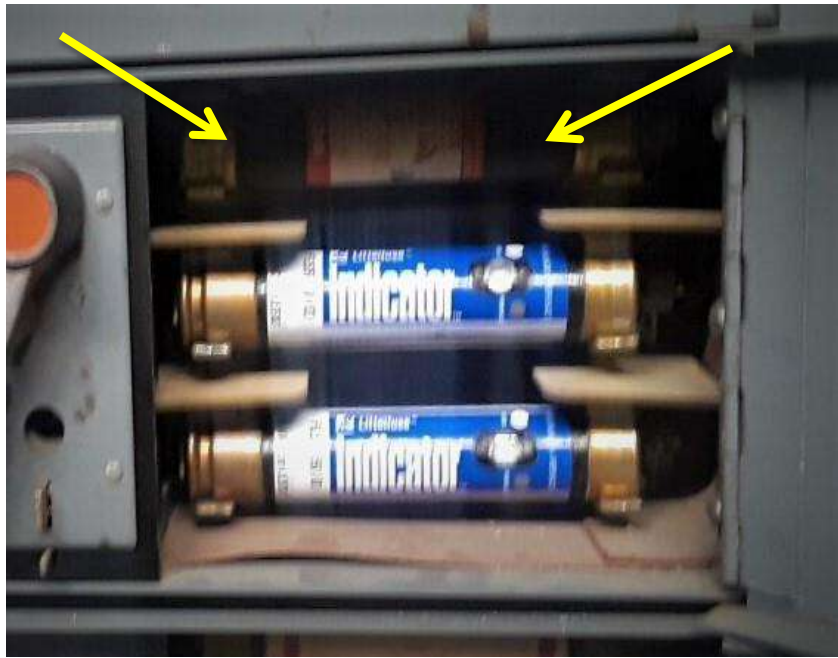
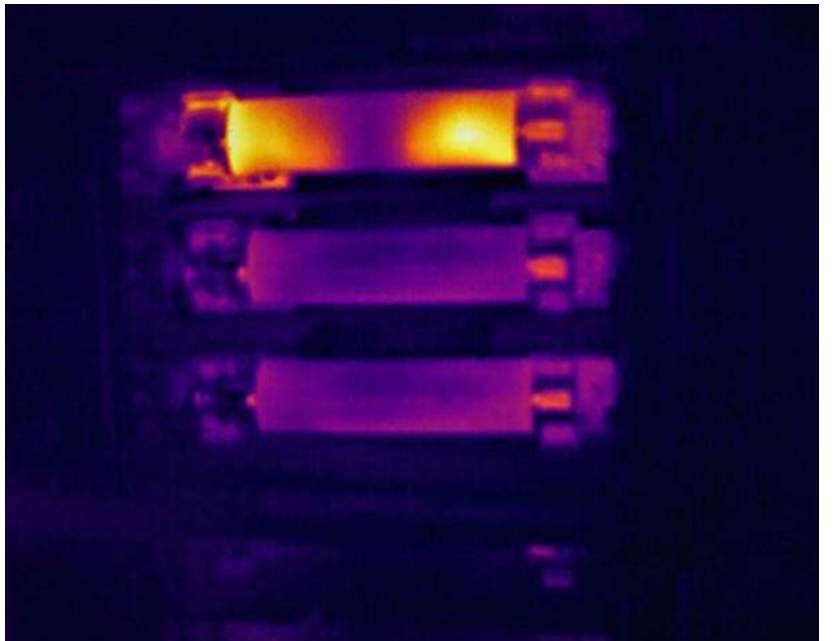
Fuse heating as indicated, Phase A, Line and Load Sides.

Clean/Tighten Fuse Connection. Replace Fuse as necessary.

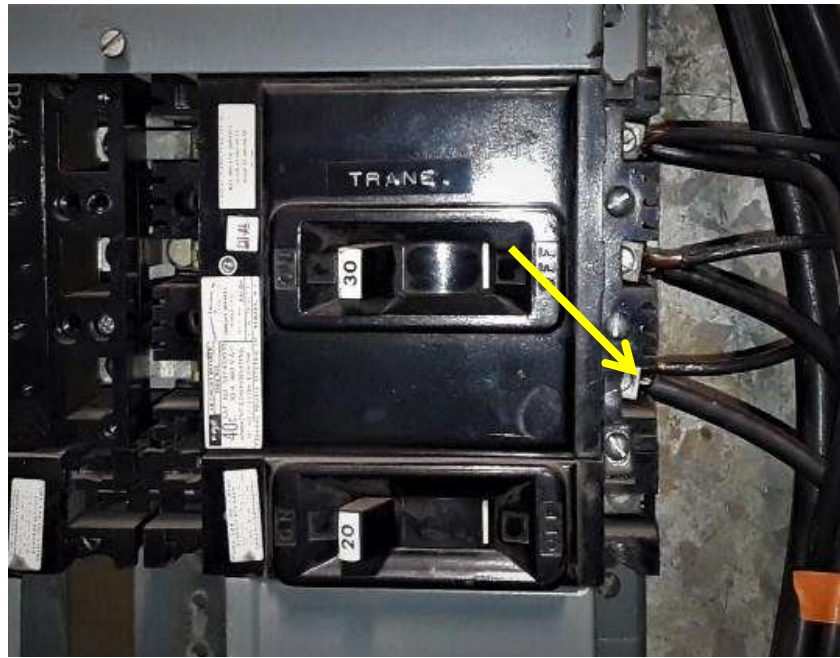
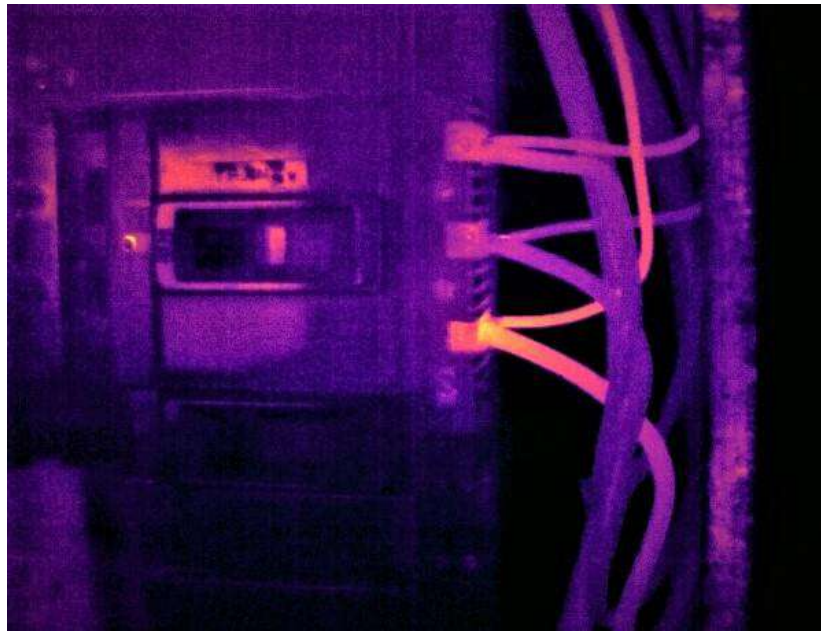
Breaker Lug heating as indicated, Phase C, Line Side.

Check/Tighten Breaker Lug connection. Replace Breaker as necessary.

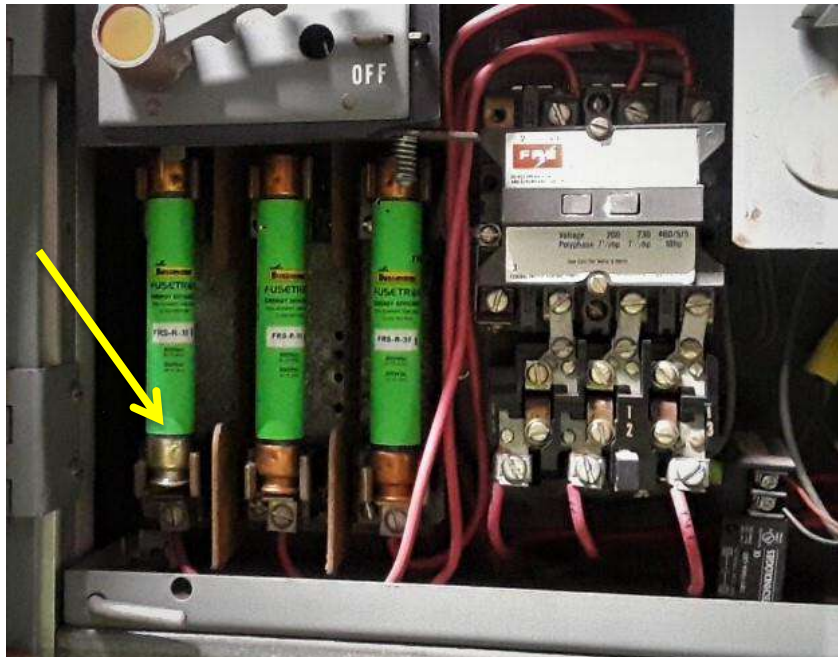
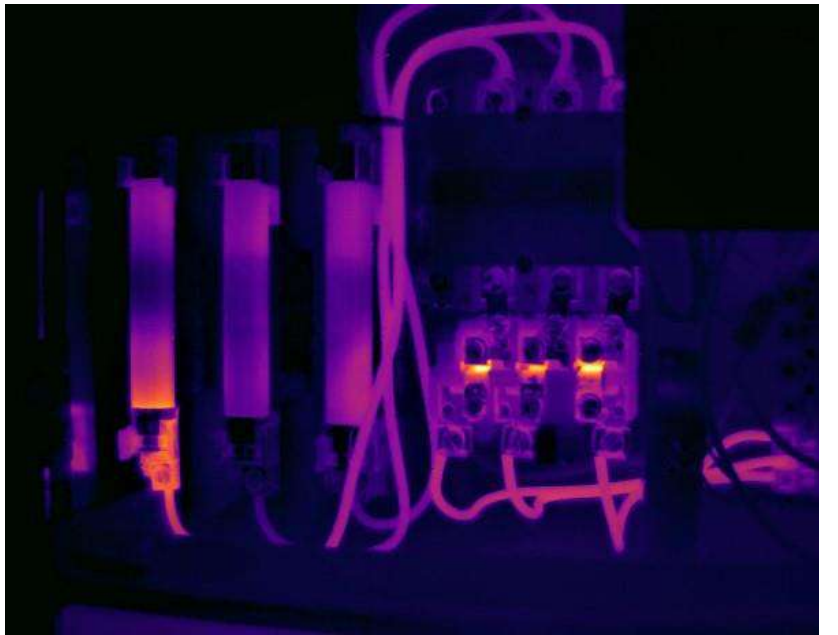
Fuse heating as indicated, Phase A, Load Side.

Clean/Tighten Fuse Clip. Replace Fuse Block as necessary.

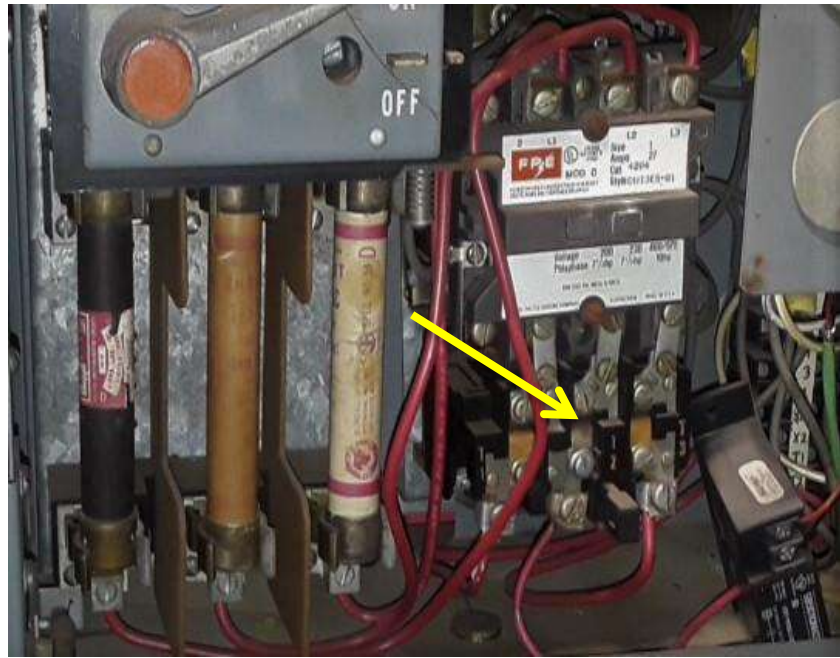
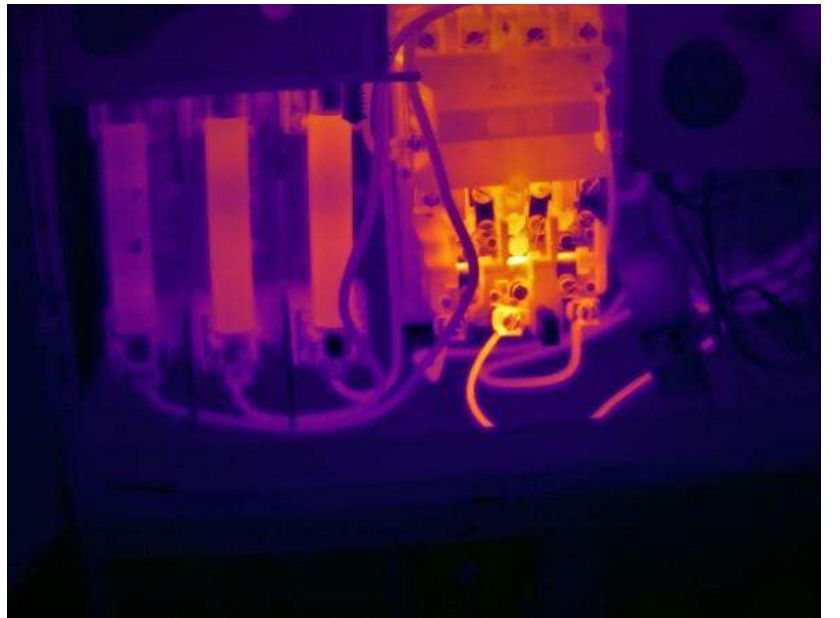
Contactor/Wiring heating as indicated, Phase A, Load Side.

Replace and Re-wire Contactor as necessary.

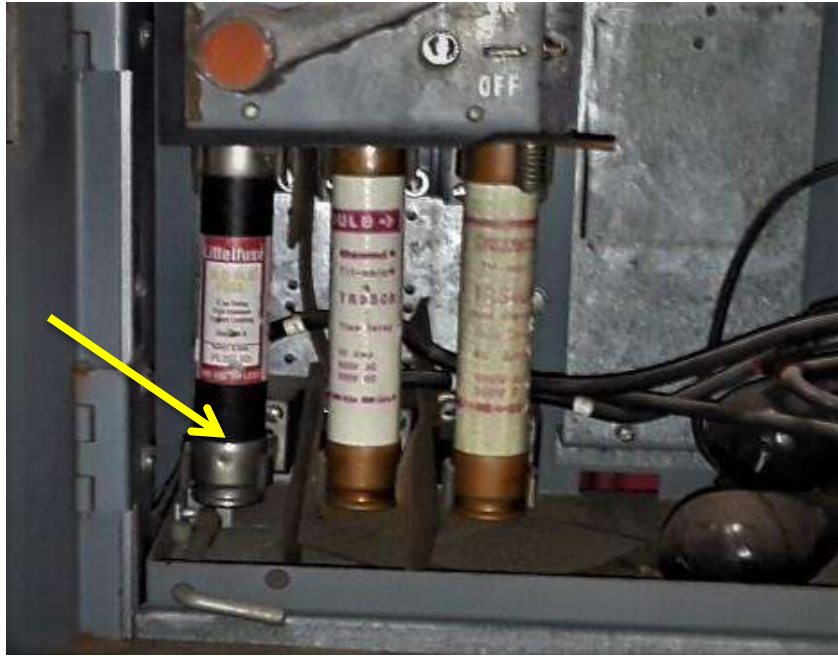
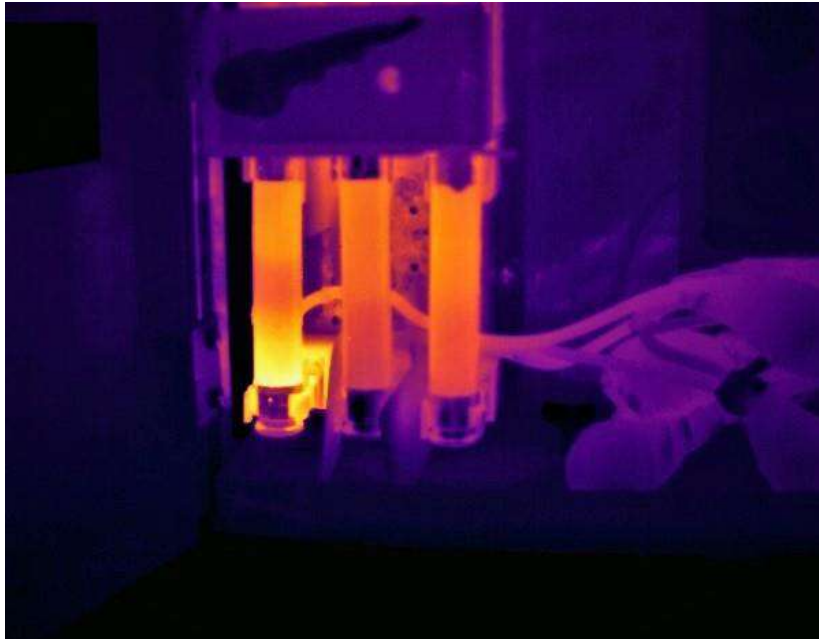
Fuse/Fuse Clip heating as indicated, Phase A, Load Side.

Clean/Tighten Fuse/Fuse Clip. Replace Fuse Block as necessary.

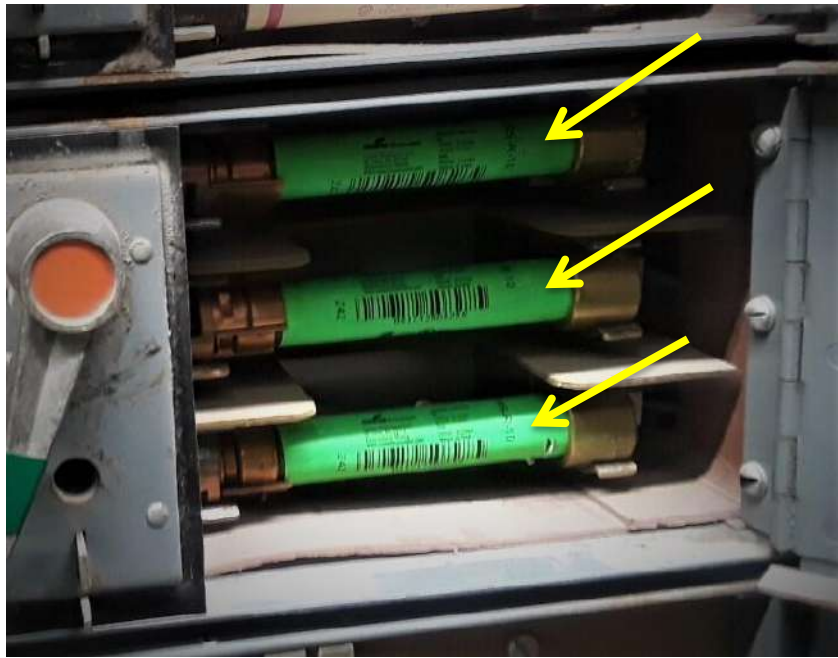
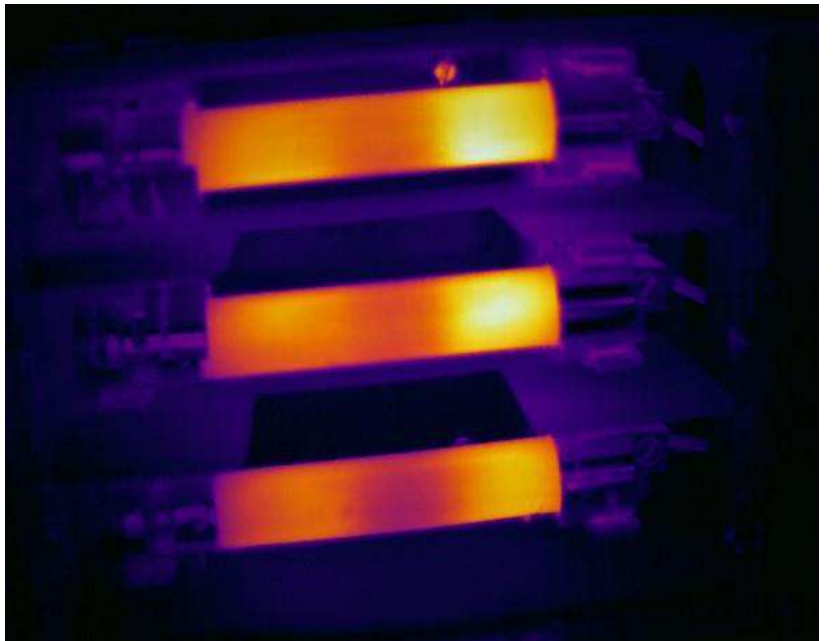
Fuses heating as indicated, Phases A, B, and C, Load Sides.

Clean/Tighten Fuses/Fuse Clips. Replace Fuse Block as necessary.
